The MacArthur Maze and Newhall Pass Fires and Their Implications for Spent Fuel Transport - 10536

Christopher S. Bajwa, Earl. P. Easton
U.S. Nuclear Regulatory Commission
Washington, DC 20555

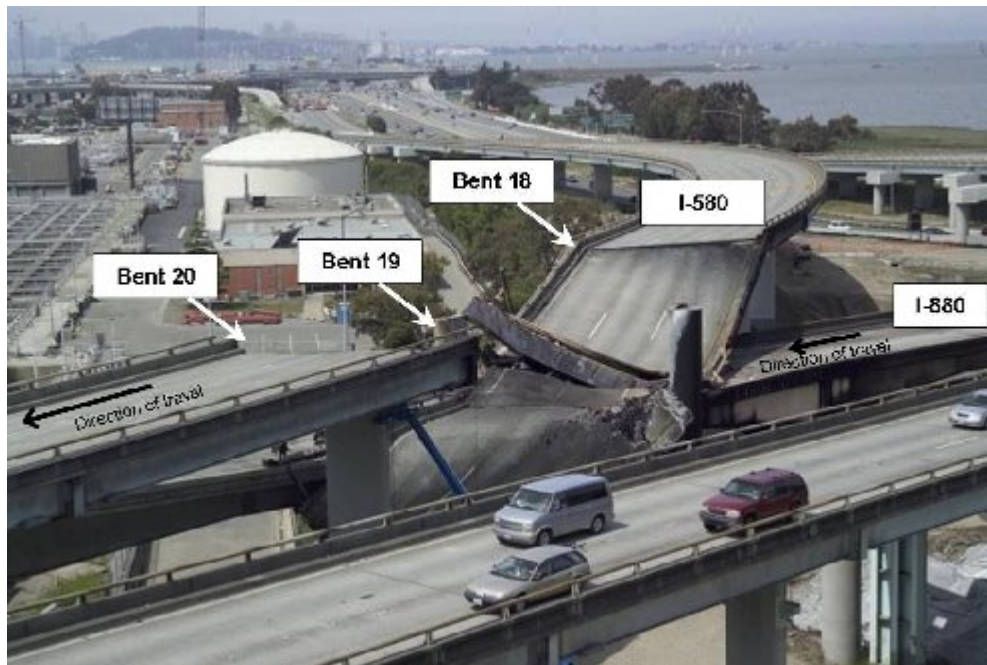
The main portion of the fire, fueled by the gasoline leaking from the tanker, spread along a section of the I-880 roadway. Some of the gasoline went through the scupper drain on I-880 and burned on the ground around an I-880 roadway support pillar. The fire on the I-880 roadway heated the steel girders on the underside of the of the I-580 overpass to temperatures where the steel strength was reduced and was insufficient to support the weight of the elevated roadway. The I-580 overpass collapsed onto the I-880 roadway about 17 minutes after the fire started, based on surveillance video taken from a water treatment plant adjacent to the highway interchange. An aerial photograph of the area with the accident site identified is shown in Figure 1 [2]. A photograph of the scene after the fire was extinguished is shown in Figure 2¹ [3].

Fig. 2. Postfire aerial view of the collapsed section of I-580 looking west. Picture from Caltrans <http://www.dot.ca.gov/dist4/photography/images/070429>.

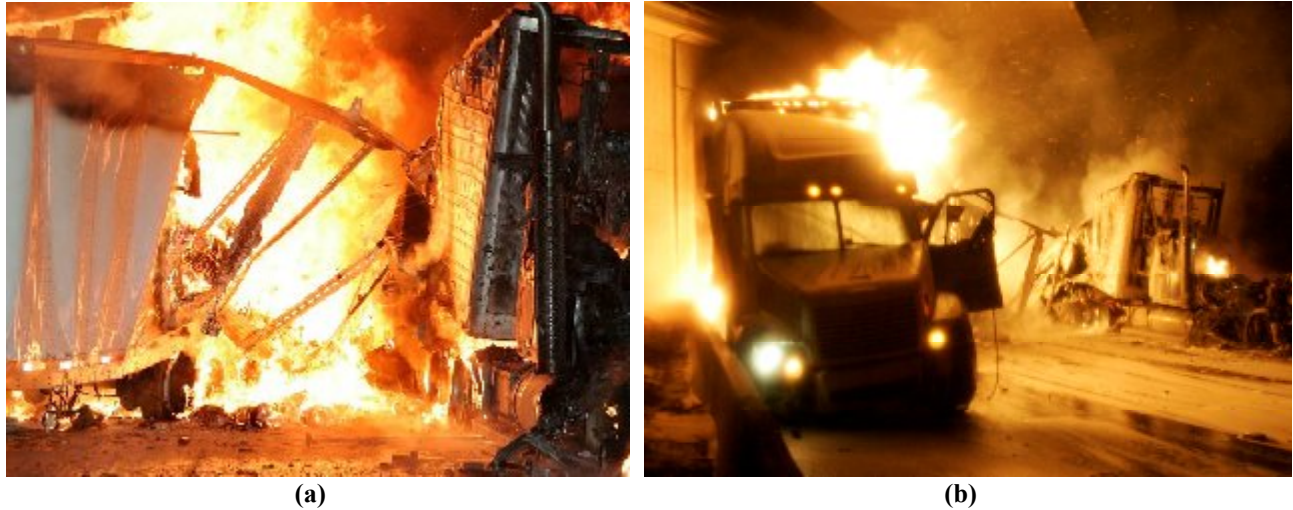
On October 12, 2007, a major fire occurred in the Newhall Pass tunnel near Santa Clarita, California at approximately 10:40 p.m. The Newhall Pass tunnel is part of the Interstate 5 southbound truck lane as it passes below Interstate 5 main lanes. The tunnel is a 165.8-m [544-ft] long reinforced concrete boxed girder, which was built in 1971. The tunnel fire was a result of a truck accident that led to a 34-vehicle pile-up in and around the Newhall Pass tunnel. One of the vehicles caught on fire and ignited the other vehicles in the tunnel. It was reported that the fire appeared to emanate from both ends of the tunnel within 15 minutes of its start (See Figure 3). An aerial map of Newhall Pass tunnel is shown in Figures 4 and 5.

Fig. 3. Images of Commercial Vehicles on Fire Outside Tunnel Exit. Photos by Gene Blevins/LACOFD/Photo.

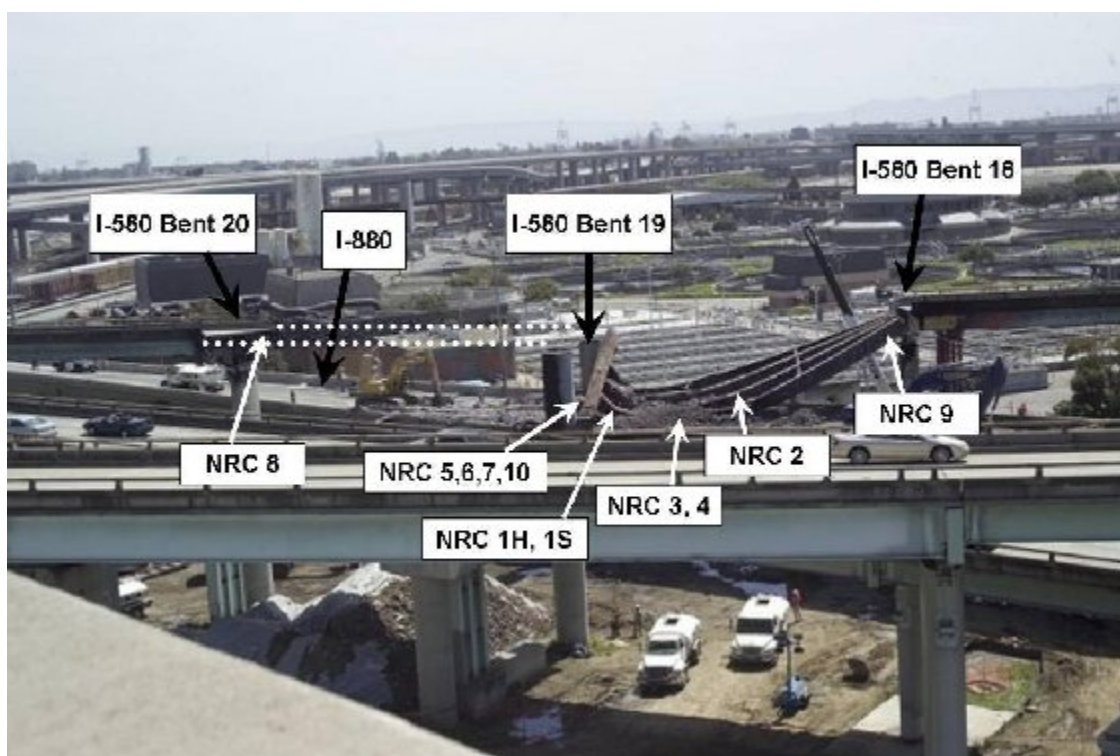
The approximate locations of the samples collected from the collapsed structure are shown in Figure 6 [3]. Table I provides a list and a brief description of the samples that the staff collected during a visit to the accident site in June, 2007.

Fig. 6. View of damage during demolition looking southwest. Bent 18, 19, and 20 and approximate locations of collected specimens are indicated. Dotted lines represent pre-accident overpass structure that was demolished and removed prior to this photograph. Original picture from Caltrans website <http://www.dot.ca.gov/dist4/photography/images/070430/index2.html>

A summary of the analysis results for selected samples is shown in Table II. Efforts were focused on the analysis of girder sections that were believed to be located close to the fire (i.e., near Bent 19) as well as samples that were known to be in much cooler locations such as near Bent 18. For example, Samples NRC 3 and NRC 4 were collected from Plate Girder 5, which was buckled during the fire. Sample NRC 3 was likely located closer to Bent 19 compared to Sample NRC 4.

As indicated above, both of these samples (NRC 3 and NRC 4) showed a transformation of the weld material due to exposure to higher temperatures.

It is apparent that no transformation of the weld occurred at temperatures of 750°C [1,382°F] or less. At a temperature of 800°C [1,472°F], the microstructure of the weld is mainly dendritic, but some small amount of pearlite is also present. In Specimen NRC 9-8, exposed at 850°C [1,562°F], the microstructure contains more pearlite but is not fully transformed. After exposure to 900°C [1,652°F], the weld is fully transformed to a ferrite and pearlite microstructure. The microstructure of the welds in the specimens exposed to 850 or 900°C [1,562 or 1,652°F] appears to be similar to the microstructures observed in welds in specimens taken from Samples NRC 3 and NRC 4. This provides additional support to the exposure temperatures postulated for these samples.

Based on the samples collected and the results of thermal exposures, the temperature of the I-580 overpass is estimated to range from 850°C [1,562°F] to approximately 1,000°C [1,832°F]. Near the truck, the maximum exposure temperature is estimated to be at least 720°C [1,328°F] and less than 930°C [1,706°F]. Results obtained from the analysis of the overpass and truck samples are consistent with modeling results, indicating the hottest gas temperatures during the fire were located above the I-880 roadway near the steel girders of the I-580 overpass. An extensive discussion of the materials analyses completed for the samples collected are provided in previous papers [4], as well as a NRC NUREG/CR series report [5].

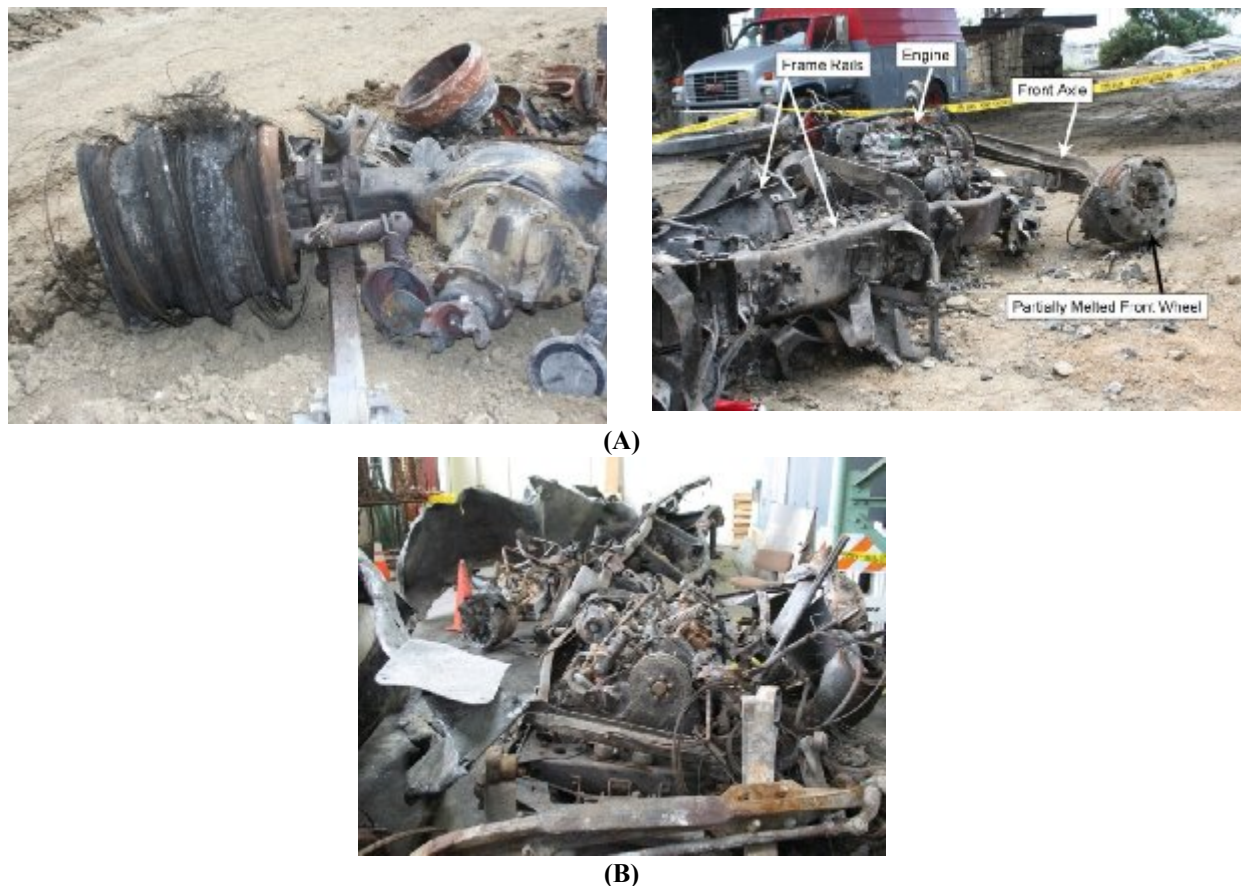
In March, 2008, staff from SwRI[®] and NRC inspected the tanker truck involved in the accident and collected selected samples for analysis. A variety of materials were collected including glass, aluminum alloys, steel, copper, brass, and stainless steel. Descriptions of the samples are shown in Table IV. Photographs of the truck remains are shown in Figure 7.

Fig. 7. Photographs of the tanker truck remains at the accident site (A) and at the Caltrans storage facility (B).

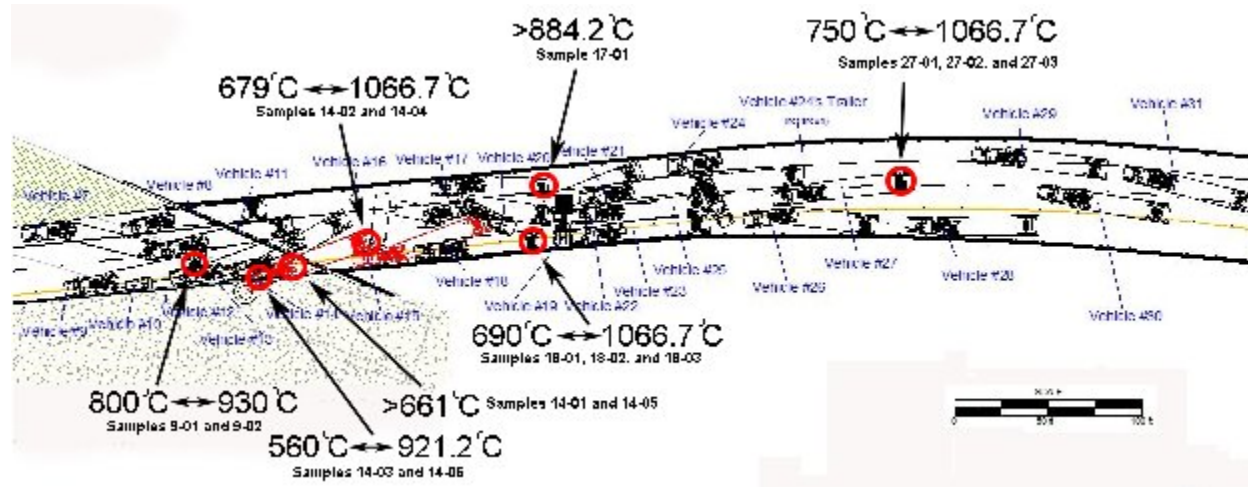
During the onsite examination of the impounded vehicles, a variety of materials were acquired including aluminum alloys, copper, brass, and steel. The metallic samples were specifically selected for their use in quantifying the thermal excursion of the fire incident. Descriptions of the samples recovered from the vehicles are provided in Table V. Figure 8 shows a schematic view of a tunnel section that includes the vehicles accessed for this study. Samples were recovered from Trucks 9, 14, 17, 18, and 27. The red circles indicate those specific vehicles and the approximate locations from which samples were acquired. The temperatures assigned to the encircled locations in

Figure 8 were obtained from the calorimetry analyses, visual inspections, and mechanical hardness measurements. Exposure temperatures were bracketed through the analysis of multiple substances obtained from adjacent locations. The temperature range provides bounds for the maximum temperature that was believed to have occurred in that location based on the materials analyses. The bounding temperature values were obtained by examining specimens that presented signs of incipient melting (only nonferrous metals) or changes in hardness values (only steel fasteners) due to the fire exposure.

Figure 8. Section of Tunnel With Vehicles Accessed for Sample Recovery. (Image of Vehicle Location in the Tunnel Was Provided by CHP.)

Figure 8 shows that for the location of Truck 9, the results from the sample analysis indicated that the temperature ranged somewhere between 880 and 930 °C [1,472 and 1,706 °F]. The material analysis determined the lower bound by examining the hardness of graded bolts and melted aluminum. The upper-bound temperature for this vehicle was determined by an unmelted brass Schrader valve, which is located a few feet off the ground.

The temperature range predicted by the materials analysis for Truck 14's tractor was between 560 and 920 °C [1,040 and 1,690 °F]. The lower bound determined from the material analysis was based on melted aluminum from the grill of the tractor. This would be expected to be slightly above the 1.5 m [4.9 ft] level. The upper bound temperature

was determined from a brass clamp recovered from the engine compartment. This would be somewhere between 1.5 and 3.5 m [4.9 and 11.5 ft].

For the front end of Truck 14's trailer the materials analysis indicated that the temperature was greater than 660 °C [1,220 °F]. There was only a lower bound because melted aluminum was the only material recovered from that location. The temperature was determined in the materials analysis by examining a section of melted aluminum flooring.

For the backend of Truck 14's trailer the materials analysis indicated that the temperature was between 680 and 1,070 °C [1,256 and 1,958 °F]. The lower bound temperature was determined by melted aluminum wheels, which would be at the 1.5-m [4.9-ft] level. The upper bound temperature determined from the materials analysis came from examination of unmelted copper wiring.

The materials analysis indicated that the temperature range for Truck 17 was greater than 880 °C [1,616 °F]. The lower bound temperature from the materials analysis data was determined by a melted brass compression fitting ferrule.

The materials analysis of Truck 18 indicated that the temperature was between 690 and 1,060 °C [1,274 and 1,940 °F]. The lower bound of temperature for the materials analysis was determined by melted aluminum around the wheel level.

The last vehicle where the materials analyses results are reported is Truck 27. The materials analyses indicated that the temperature was at least 750 °C [1,382 °F] but did not reach 1,070 °C [1,958 °F]. The lower point on the materials analyses came from the hardness of a graded bolt. The bolt microstructure indicated it had been converted to pearlite; However, the upper-bound temperature from the materials analyses came from an unmelted plate on the axle.
