Weld Repair of a Stamped Pressure Vessel in a Radiologically Controlled Zone – 14006

ABSTRACT

INTRODUCTION

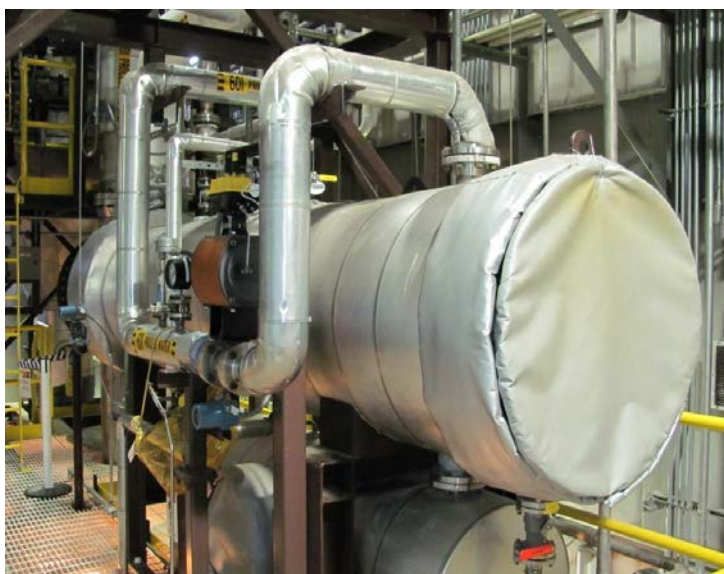
The vessel, shown in Figure 1, is a two pass shell and tube heat exchanger with an outside diameter of 914 mm and a length of just under 5.5 m. Steam on the shell side of the vessel transfers heat to chemically and radioactively contaminated brine on the tube side. Solids in the boiling brine stream are concentrated as it is pumped through the vessel via an axial flow recirculation pump at about 455 l/sec. The brine side of the vessel, including the tubes, is constructed from Inconel Alloy 625 (ASME SB-443 625), and the steam side is constructed from 304L stainless steel.

Fig. 1. Overall view of the ETF Heat Exchanger – repair area is at the far end.

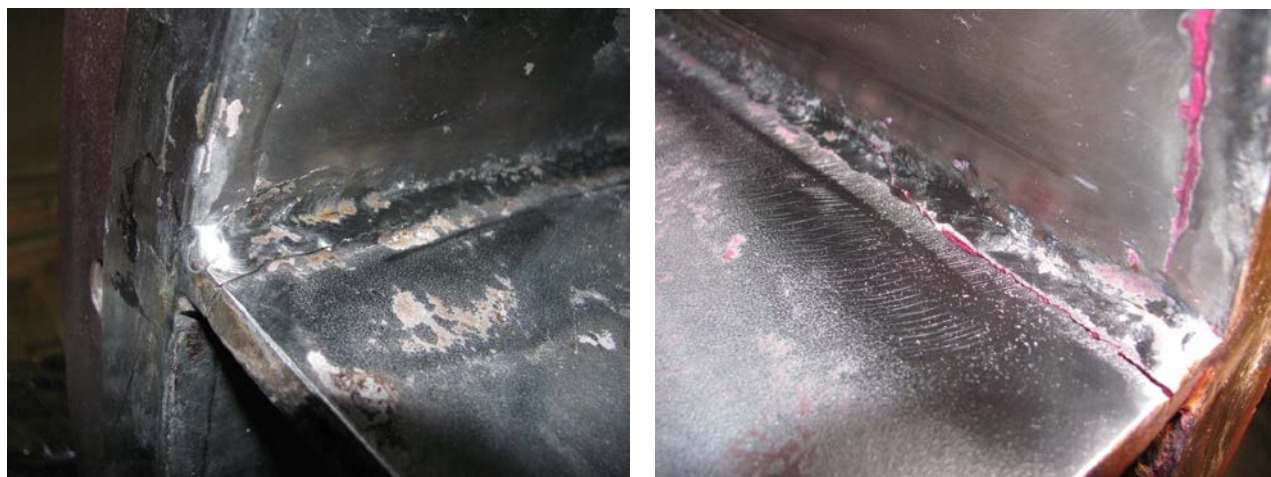
Fig. 2. Cracking at the shell / pass partition plate welds.

vessel at the shell / pass partition plate welds (Figures 2). Cracking extended from the end of the pass partition plate (at the blind) 100 – 150 mm along the weld passing through base, HAZ and weld metal. In addition, a linear region of affected base material, running in a circumferential direction near the end of the shell was noted (Figure 3).

Material fatigue, resulting from cyclical loading, appears to have been the cause of cracking. Impingement of the brine flow against the plate is believed to have set up flow induced vibration and cyclical stress, especially at the “free” end. Fatigue cracks tend to initiate at stress risers, which would include the notch at the root of the fillet weld (inherent in the joint design) and the undercut at the toe of the weld. The cracks observed are associated with these features and are consistent with classic fatigue crack travel and propagation. As noted a formal failure analysis was not performed; however, given the nature of the failure, appearance of the cracking, location of the cracking, absence of localized corrosion and an understanding of materials performance, it is believed the most likely cause of failure was fatigue.

program. Repair consisted of removing the defects by grinding and defect removal was confirmed by PT. Once confirmed, the excavated area was prepared (with a groove sufficient to accommodate a stringer bead(s)) and welded using the Gas Tungsten Arc Welding (GTAW) process. Care was exercised to ensure the shell was restored to its original thickness. Through-wall defects were welded from both the interior and exterior sides of the shell.

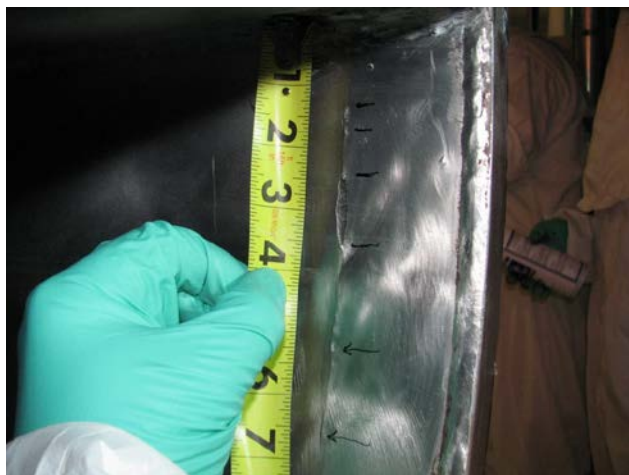
Fig. 3. Circumferential, linear indication – affected base metal.

The “linear” region of affected base material noted above, appeared to be weld metal burn through; this region lined up directly behind the OD flange to shell fillet weld. It is believed this condition originated during initial fabrication welding of the vessel.

It was noted above that a linear region of affected base material (approximately 178 mm in length), running in a circumferential direction near the end of the shell, was visually identified – see Figure 3. The condition is believed to have been caused by weld metal burn through during initial vessel fabrication - this area lined up directly behind the fillet weld attaching the OD flange to the shell. This area was prepared by grinding (light blending) and welded by depositing a stringer bead(s) sufficient to restore the shell to its original specified thickness.

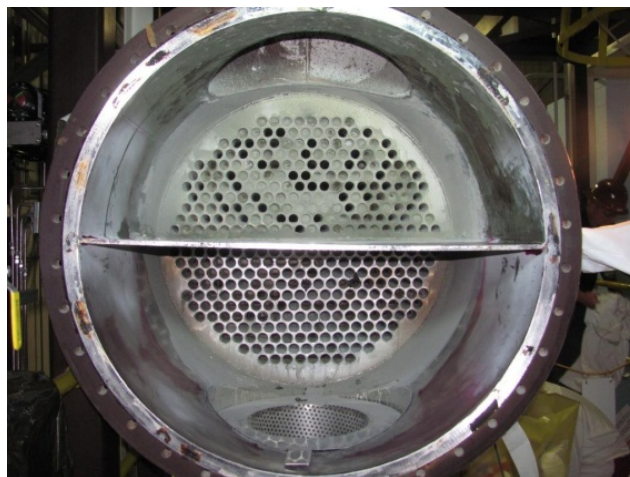
Figure 4 shows the 9.5 mm thick, Alloy 625 pass partition plate welded to the 4.8 mm thick shell ID (two sides) and to the tube sheet. The remaining side butts against the Channel Blind, but is not secured or supported, leaving it free to flex when loaded by the incoming 455 l/sec brine flow through the inlet nozzle. Failure (cracking) occurred in the plate-to-shell welds and in the partition plate as shown in Figure 2. Cracking extended along the toe of the welds, into the plate, veered out into the plate and then back into the weld. UT examination (along with subsequent visual inspection of the shell ID) indicated that neither general nor localized corrosion processes were active. No physical deformation (material strain) was observed at the area where cracking was observed.

Fig. 4. View into the open end of the vessel showing the pass partition plate and tubes.

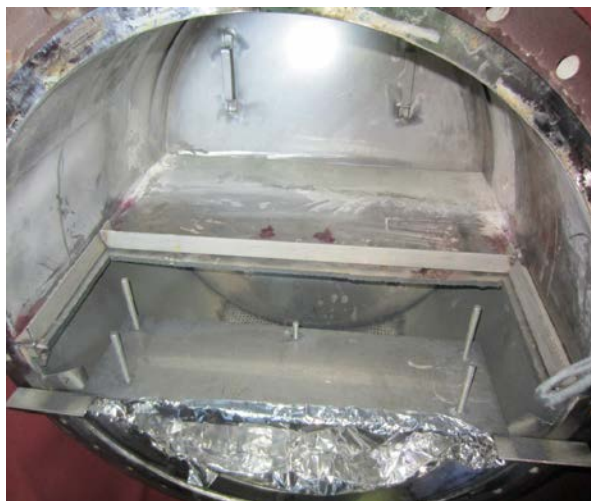
Fig. 5. Section of pass partition plate removed – leaving a 3/4-in piece along the

A section of the plate, measuring approximately 230 mm deep by 890 mm wide, was removed using a plasma arc cutting torch. The cut line on the plate running parallel to the shell axis was placed approximately 20 mm inward from the shell – see Figure 5. This was done to avoid any potential impact (wall thinning) on the shell thickness. The remaining piece of plate and the two attachment fillet welds were completely removed by grinding. The shell ID surface was now fully accessible for evaluation and was examined (on both sides of the shell) by VT and PT to establish the extent of cracking – see Figure 6. Visual examination revealed no indications of corrosion at the plate / shell interface. Liquid penetrant examination disclosed numerous linear indications on both the exterior and interior shell surfaces where the plate was attached to the shell.

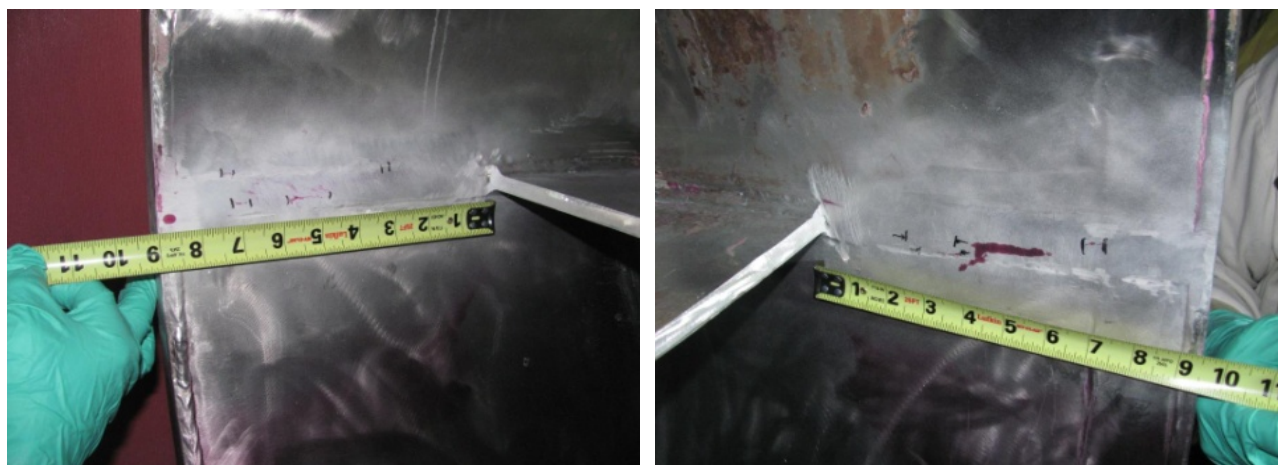
Fig. 6. Shell ID after pass partition plate removal.

On several occasions, PT of the repaired areas disclosed indications adjacent to the repair; indications that were not identified by PT prior to weld repair. It is believed the new indications were “incipient”, and along with the other identified cracking, the result of fatigue loading. These “new” cracks opened up, sufficient to be disclosed by PT, as a result of shrinkage stress caused from repair welding. All defects were removed, verified by PT, weld repaired and PT examined for acceptance.

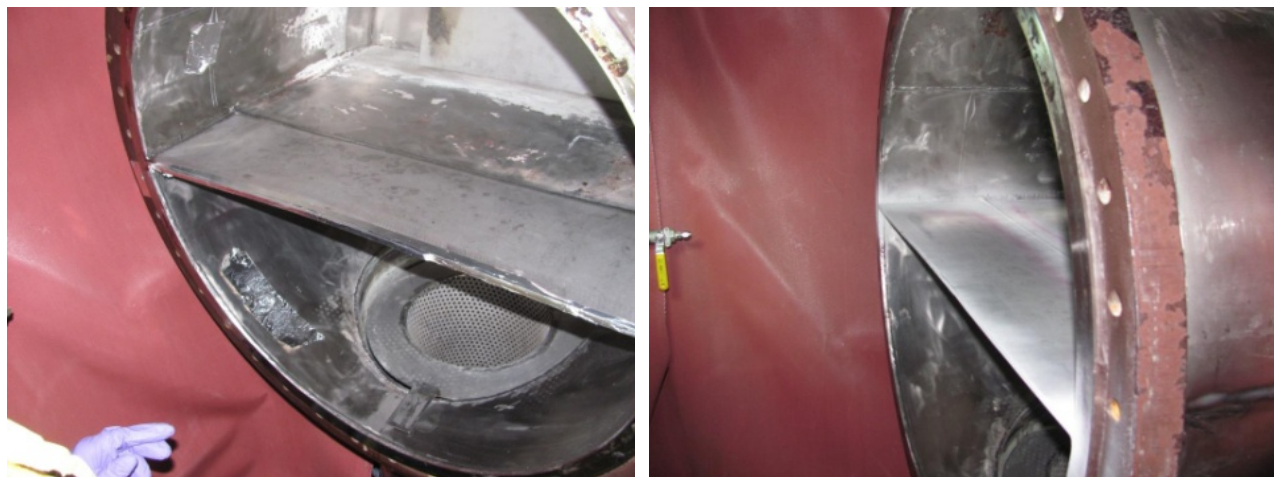
Fig. 7. New piece of Inconel plate installed and inspected.

With weld repairs complete, including acceptable VT and PT inspections of the repaired areas, a section of new Inconel plate was installed to restore the pass partition plate to its original dimensions. The new plate was machined with a K-bevel for full-penetration welding to the remaining piece of installed plate and the two sides, attaching to the shell, were given a square end prep to accommodate the two fillet welds. The new plate piece was installed and inspected by VT and PT – see Figure 7.
