**Hanford Double-Shell Tank AY-102
Radioactive Waste Leak Investigation Update – 15302**

Dennis J. Washenfelder *, Jeremy M. Johnson **

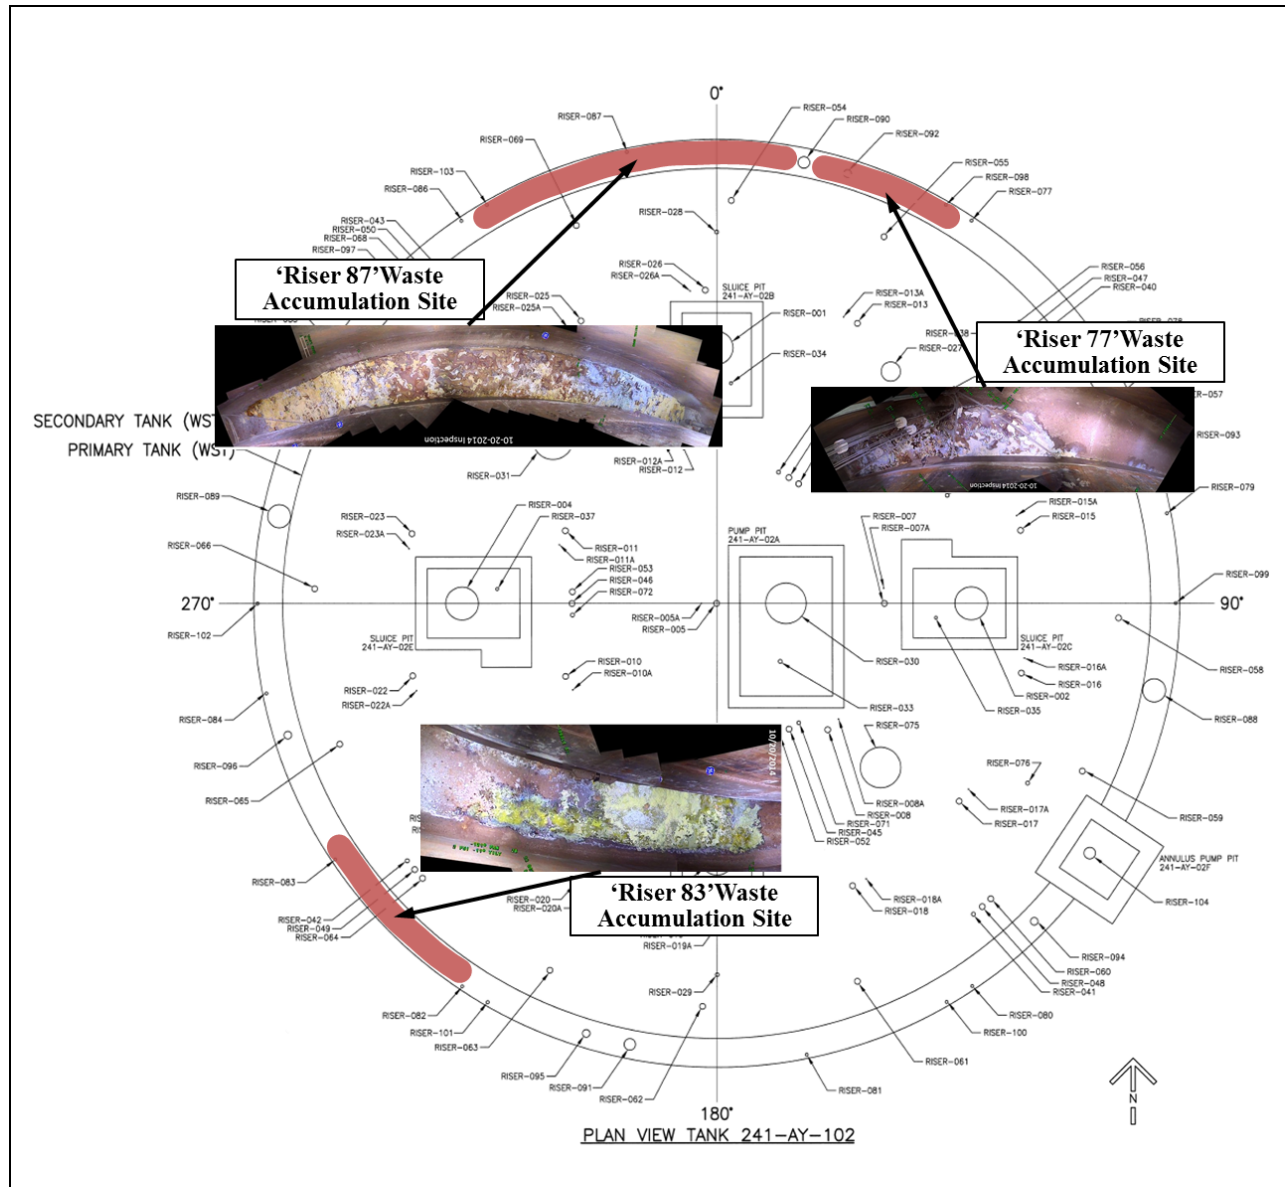
Fig. 2. Tank AY-102 Annulus Waste Accumulation Sites, October, 2014

Waste was first observed on the annulus floor of tank AY-102 in August, 2012, during a scheduled annulus video inspection. Small accumulations were visible near Riser 87 in the northwest tank quadrant and near Riser 83 in the southwest quadrant. These were not present during the last inspection conducted December, 2006 – January, 2007. The reported volume was estimated to be 0.15 – 0.26 m³ (40 – 70 gal) of drying material at the two sites and nearby air cooling channels in the insulating refractory pad. A sample of material taken from the Riser 83 accumulation site in September, 2012, was confirmed to be tank waste. A third accumulation site formed during February, 2014, near Riser 77 in the northeast quadrant.

After initial discovery of waste in the annulus the accumulation sites were observed twice weekly for additional change. The seepage of new material was episodic with periods when no change could be observed. In December, 2012, the observation frequency was reduced to once weekly, and in December, 2013, once every two weeks, which is the current frequency. As of October, 2014, the estimated leak volume accumulated on the tank annulus floor is 0.14 m^3 (36.7 gal) (refer to Figure 2). The material accumulation rate for the period April – October, 2014 ranged from $0.002 \text{ m}^3/\text{mo}$ to $0.10 \text{ m}^3/\text{mo}$ (0.7 gal/mo to 2.7 gal/mo), with a decreasing trend. The average accumulation rate for the six month period was $0.005 \text{ m}^3/\text{mo}$ (1.4 gal/mo). There is no correlation with weather changes such as relative humidity or air temperature of the annulus ventilation air. There is no evidence of additional accumulation sites forming.

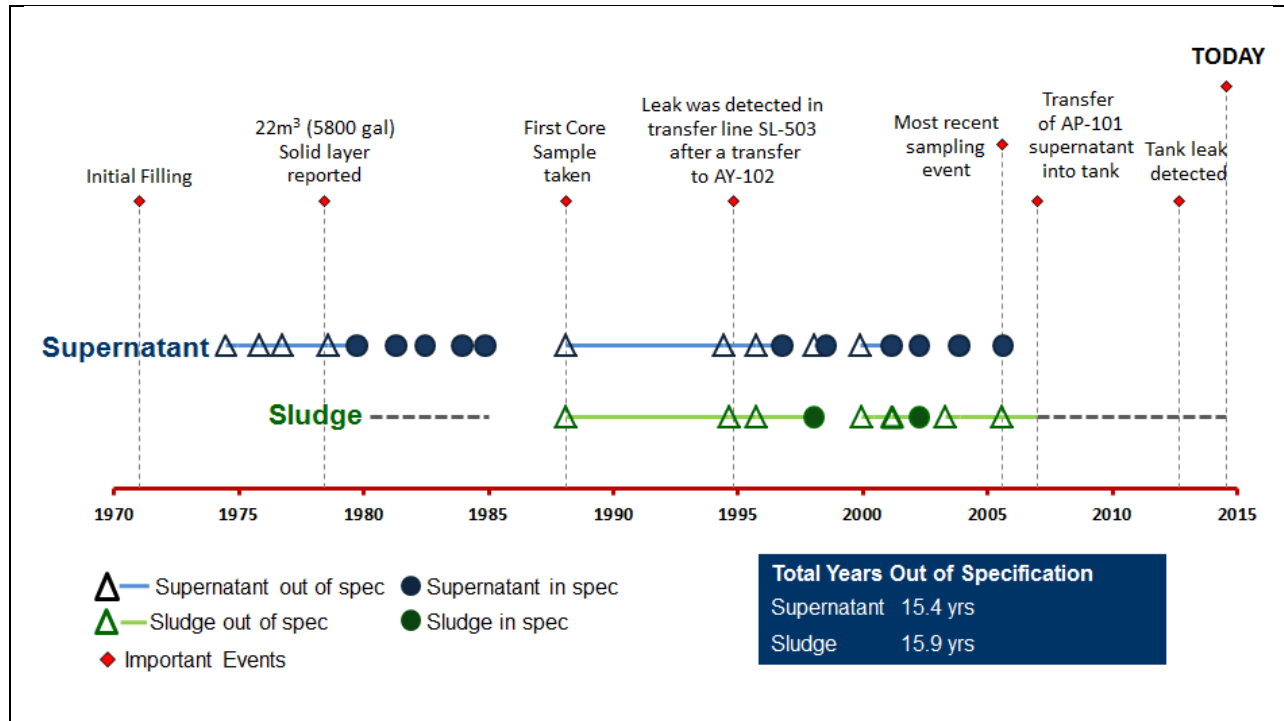
Fig. 3. Tank AY-102 Operating History

Comparing the existing corrosion specification to tank AY-102 historical supernatant and sludge sample compositions indicated that the supernatant waste has been out-of-specification for 15.4 years, and the sludge waste out-of-specification for 15.9 years. In other words, since the tank was first placed in service at least a portion of the waste was outside of the existing corrosion specification about 37% of the time (refer to Figure 3).

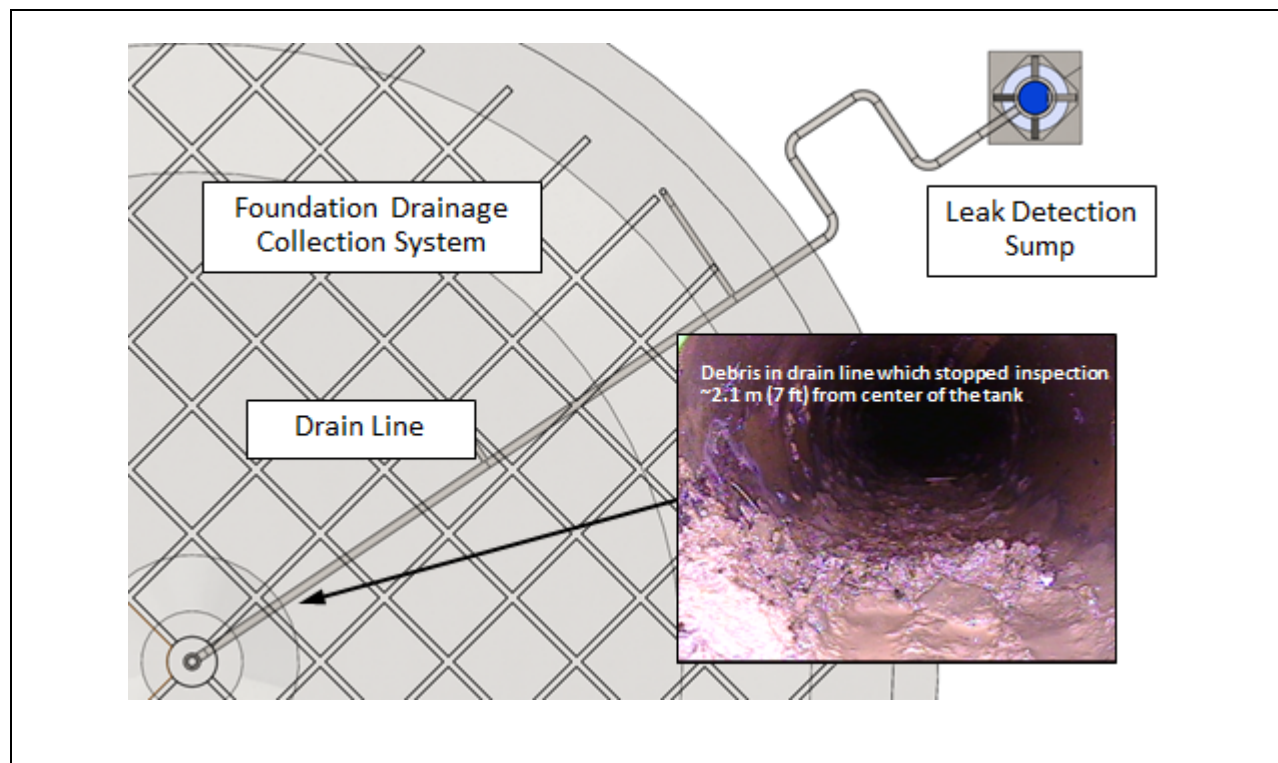
Fig. 4. Tank AY-102 Leak Detection System Inspection, November, 2013

This was confirmed in November, 2013, by a robotic inspection of the drain line between the collection sump and the foundation drainage system. The inspection showed that the majority of the drain was dry with debris collected in localized areas. There was no visual evidence of

leakage, and the contamination levels were consistent with those found in the sump. The inspection covered the entire length of the drain line to within 2 m (7 ft) of the tank’s center before high-centering on debris (refer to Figure 4) [20].

The water accumulation in the sump is believed to result from differential air pressure across the slide plates separating the tank’s concrete sidewall from its foundation. The differential pressure from the annulus ventilation system extracts soil moisture across the slide plate interface where it collects in the foundation drainage grooves and drains to the sump. The origin of soil moisture is rainfall and snowmelt that wicks down the outside of the tank and gathers at the slide plate location. The slide plate design used in tank AY-102 is unique to the early double-shell tanks. Later tanks used a modified design and do not experience a similar water accumulation.
