Savannah River Site

Tank 18 and Tank 19 Wall Sampler Performance

ABSTRACT

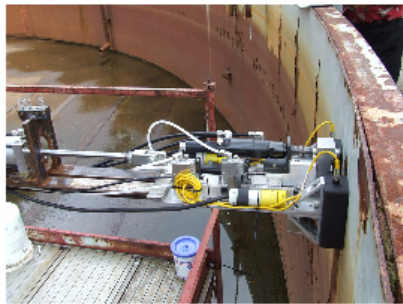
Full scale testing

To ensure sampling success in the waste tanks, the completed mast and sampler were evaluated during full scale testing. Evaluation at the mockup facility consisted of installing the mast by crane through a full scale riser opening, lowering the mast into position, operating the sampler, removing the mast assembly by crane, and removing and packaging a sample. These steps were performed using the same mast mounted camera equipment available to FTF. Other than the huts at the tank tops and contamination concerns, full scale testing conditions were comparable to FTF. A few minor changes were made to the mast, but it functioned as designed, and workers learned to operate the equipment efficiently before working in FTF. The first holes were drilled in a clean ground surface on the Full Tank wall. The initial attempts to drill rusted surfaces were ineffective.

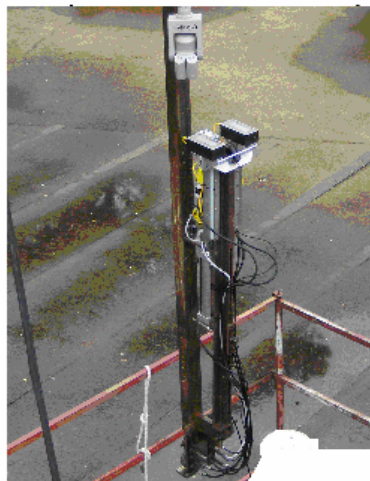
Sampler and mast assembly

To reduce costs, a simplified sampler and mast assembly was designed, tested, and installed in the waste tanks (Figure 3). In comparison, West Valley deployed the sampler using a reported 50 million dollar robotic arm. Based on their work, SRS developed a simplified and improved design. Total costs were less than five million dollars to obtain wall samples, where the cost of the sampler fabrication and evaluation was approximately \$400,000 and estimated costs for sample analyses are \$300,000 to \$400,000. A 45 million dollar cost savings was realized by SRS from the novel design.

The mast design used supplied sampler and sampler heads, and the completed assembly consisted of several major components. The mast assembly was encased in a flexible plastic sleeve to maintain radioactive contamination control. Although not used in full scale testing, the sleeve connected to a yellow plastic hut built for working with the sampler, and as the mast was lowered into a tank, the sampler was accessed in the hut. The base of the sampler was a 3 inch thick plate designed to cover 23 inch riser openings at the tank tops. The vertical mast was raised, or lowered through this plate and fixed in position to obtain required heights for wall samples. The cantilevered arm was hinged at the bottom of the mast, and the controls were connected at the top of the mast. The sampler was positioned near the end of the arm, and was lowered into position using a cable connected to a manually operated winch, which was located above the tank. When the arm was lowered, a level was observed on the arm with a remote camera to level the arm to the correct elevation in the tank at either FTF or during full scale testing. Once the arm was leveled, an air actuated cylinder then guided the sampler along the arm until the electromagnets touched the wall. A mast mounted camera was then used to ensure that the electromagnets were properly aligned before energizing the electromagnets. The level was re-checked, and sampling was performed. To obtain samples, the sampler control system was operated to collect a sample from the wall. A mast mounted camera and a fixed focal length camera mounted to the bottom of the sampler were used to determine that the sample was complete. Although a recommended time to machine a sample was used to direct the sampling

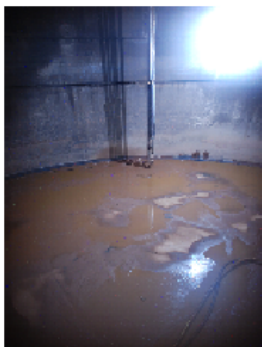
Tank 19 Sample Results

Tank 19 wall and floor

Upper and lower sample results

In Tank 19, the walls were cleaned by pressure washing prior to initiation of sampling and the sampler drilled holes as expected. Two holes were drilled with each of two samplers and the samplers were transported to SRNL. Surface areas were simply equal to the area of the drilled hole. After delivery to SRNL, all returned sampler heads were disassembled and carefully cleaned to ensure that all material was collected for further analysis.

In Tank 19, drilling of samples was performed similar to SRNL testing. Samples had lower radiation rates (13 and 37 mRem extremity) All Tank 19 sampling was completed in less than a day.
