Closure of the Reactor Maintenance, Assembly, and Disassembly Facility and the Pluto Disassembly Facility at the Nevada National Security Site: American Recovery and Reinvestment Act-Funded Acceleration of Demolition and Lessons Learned – 11157

Annette L. Primrose*, E. Jeanne Poling*, Thomas A. Thiele*, Reed J. Poderis*, David M. Nacht*, James L. Traynor*, Alissa J. Silvas*, Robert Boehlecke**, and Kevin Cabbale**

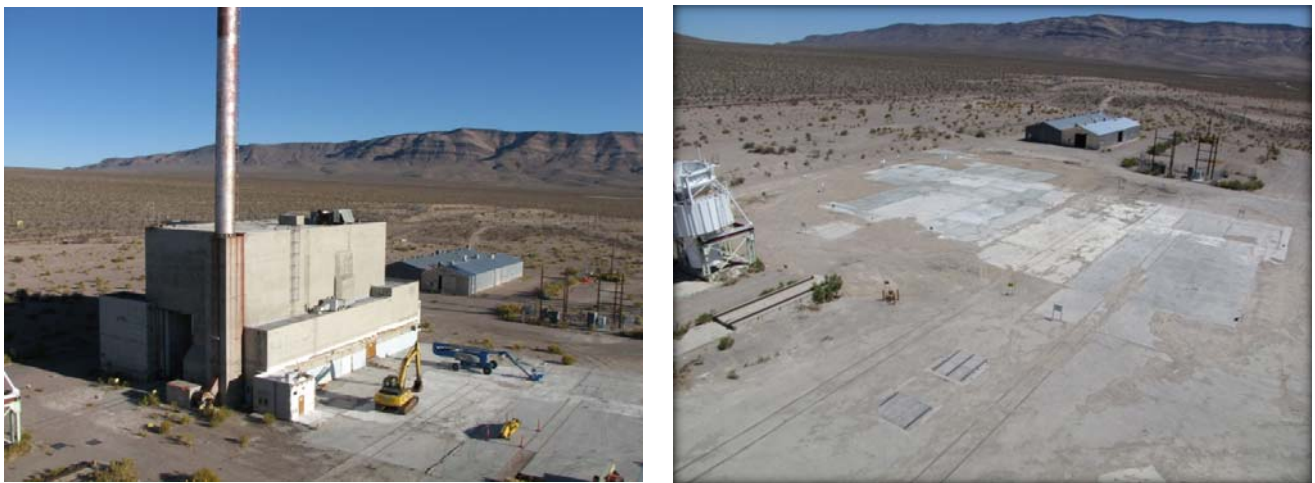
Fig. 1. Before and after photos of the R-MAD Facility.

The R-MAD Facility was built to support the nuclear rocket program and was operational from 1959 through 1970. It was used to assemble reactor engines and to disassemble and study reactor parts and fuel elements after reactor tests. The non-radiologically contaminated portions of the facility were demolished in late 2005.

Demolition activities for the radiologically contaminated portions of the R-MAD Facility were initiated in October 2009, with the funding made available through the ARRA. Demolition activities included removal, packaging, and disposal of insulation of pipe elbows and roofing material containing asbestos; conventional demolition of the non-high bay structures; explosive demolition of the water tower and large stack; and use of explosives to lower the high bay followed by conventional demolition. Building debris was used to fill the basements, which were then capped with 30 centimeters (cm) of grout/concrete. The remainder of the debris was packaged and transported to the NNSA Area 5 Radioactive Waste Management Complex (RWMC) for disposal. After disposition of the building debris, the area was posted as a use-restricted area for polychlorinated biphenyls (PCBs) and radionuclides associated with the building pad and basements. Demolition of the R-MAD Facility was completed on July 15, 2010, and demobilization activities were completed on August 31, 2010.

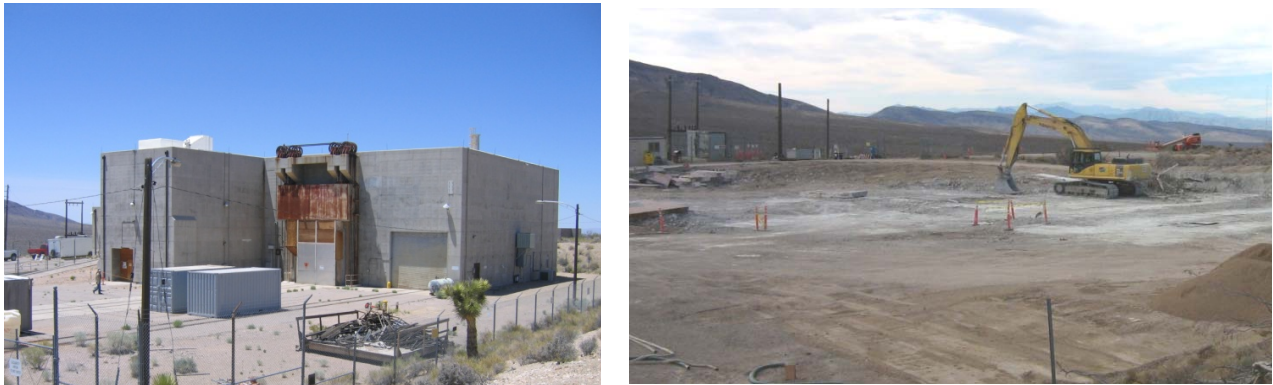
Fig. 2. Before and current photos of the Pluto Facility.

The Pluto Facility was used to support design and testing of nuclear reactor-powered missiles and was in use from 1960 until 1964. Preliminary site investigation activities were conducted in May and June 2007, including collecting samples of paint, oil, flooring material, and surface smears. Radiological swipes and surveys also were conducted, and swipe samples for beryllium and lead were collected. Closure activities conducted under the FFACO occurred from May 2008 through March 2009. Closure activities included tapping and draining utility systems and equipment reservoirs, investigating vaults, removing leaded glass shield windows and hazardous material (such as lead and PCBs), remediating soil, and placing final postings and markings. The FFACO closure of the Pluto Facility was achieved on July 6, 2009, with approval of the Closure Report by the Nevada Division of Environmental Protection [2].

The ARRA-funded demolition of the Pluto Facility started in October 2009 with preparation of the facility for demolition. Demolition preparation activities included radiological surveys; radiological decontamination; equipment strip out; and removal, packaging, and disposal of radiologically impacted items, and asbestos-surfacing material. Explosive demolition of the water tower was completed in February 2010, and demolition of the facility using traditional methods began in September 2010. Radiological decontamination activities and extensive radiological surveys performed during demolition preparation allowed the building rubble to be used as fill material. This resulted in cost savings by reducing the cost for importing fill material required at the disposal location, and avoiding the cost of packaging the waste. Shipping of the building rubble to the NNSA Area 5 RWMC for use as fill began in September 2010.

Additional building rubble was used to fill the basement, which will be capped with 30 cm of concrete. Demolition of the Pluto Facility is anticipated to be complete by January 2011, and all demobilization activities are anticipated to be complete by February 2011. The final configuration will include an underground radiological material area at the former facility.
