**The Relocation of Waste Trench #54 at the Port Granby  
Waste Management Facility, Municipality of Clarington, Ontario, Canada - 11280**

**ABSTRACT - 11280**

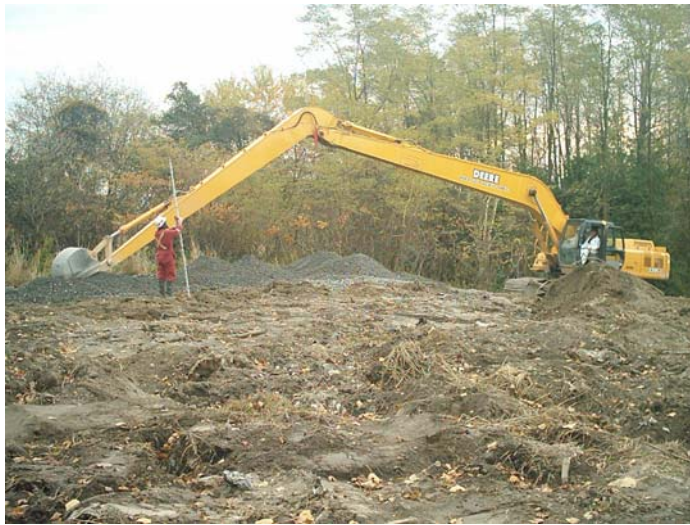
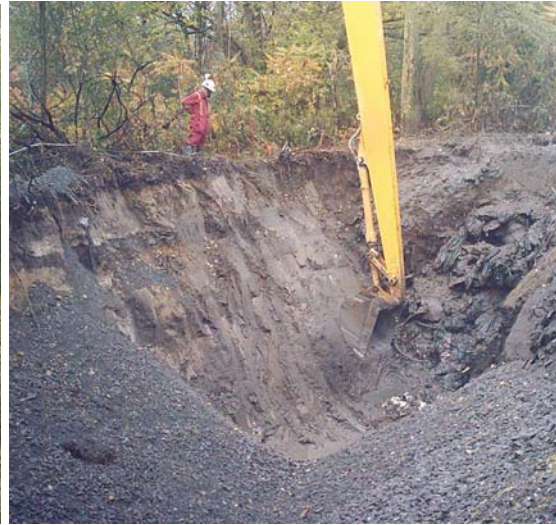
In total, approximately 800 m<sup>3</sup> of buried waste material was removed, consisting of but not limited to filled garbage bags, drums at the upper portion of the trench and calcium fluoride at the lower portion. The excavation was carried out using an extended boom (John Deere Long Reach 330C LC) excavator depicted in Figure 2. This type of excavator provided a reach of approximately 18.3 m. The excavator was positioned at a safe distance away from the north crest of the excavation slope. The native soil wedge between the waste excavation and the erosion scarp was left in place.

**specialized extended boom excavator**

**excavation in progress**

Fig. 2. Excavating with the specialized extended boom excavator.

The work was implemented in a safe, staged manner, which maintained the stability of the natural slope during the excavation procedure. Portions of the excavation were limited to 5 m lengths and each portion was backfilled prior to proceeding to the next stage. The excavation face was contoured prior to backfilling and the natural slope was monitored to ensure that the stability of the embankment was maintained during the remedial work as depicted in Figure 2. All excavated material was kept away from the crest of the slope and deposited within the area of the new storage mound.

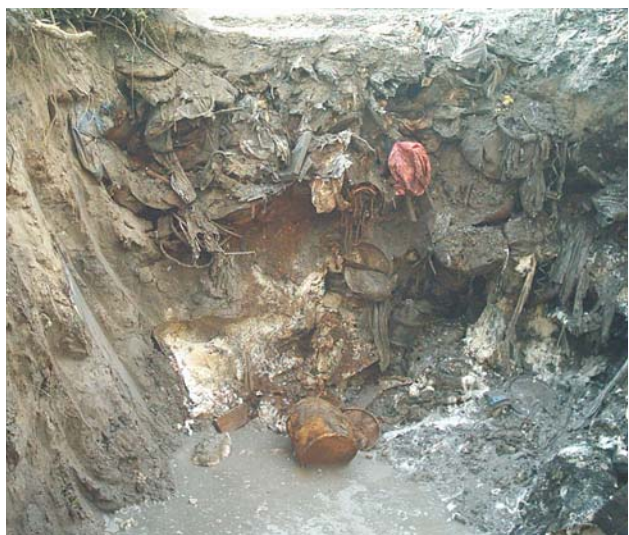
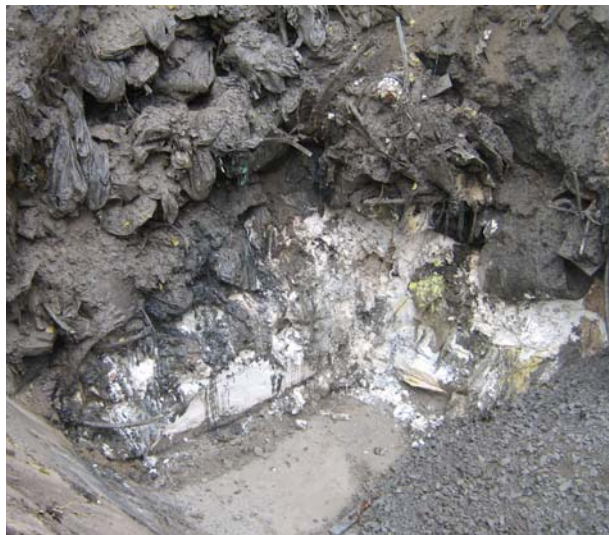
The remedial excavation encountered 1 m of clean soil and then industrial waste to a depth of 5 m below the ground surface. There were no distinct layers or 'lifts' of refuse. The observed waste material included items such as old motors, drums, cans, plastic sample containers, garbage bags, cables, wiring, concrete rubble, bricks and metal fragments. A limited quantity of UF<sub>4</sub> and U<sub>3</sub>O<sub>8</sub> was also encountered, likely from the production of depleted uranium metal. A 0.4 to 0.6 m thick layer of white calcium fluoride was encountered near the base of the excavation. The material was alkaline and exhibited a 'paste' texture. Figure 3 depicts a typical view of the exposed wastes within Trench #54.

**waste material**

**white calcium fluoride**

Fig.3. Exposed refuse in Trench #54.

Backfill was placed in the excavation at the end of each day to cover exposed wastes and to stabilize the near vertical face along the south and east portions of the excavation. The backfill consisted of crushed limestone material (75 mm maximum particle size) from a local quarry. In total, approximately 600 m<sup>3</sup> of crushed limestone backfill was placed to approximately 0.6 m below the crest of the excavation slope and was capped with approximately 200 m<sup>3</sup> of topsoil (0.3 m thick). Backfilling of the excavation was completed by October 27, 2009. A shallow swale was excavated into the final cover to direct drainage from west to east towards an existing ditch along the east boundary of the PGWMF.

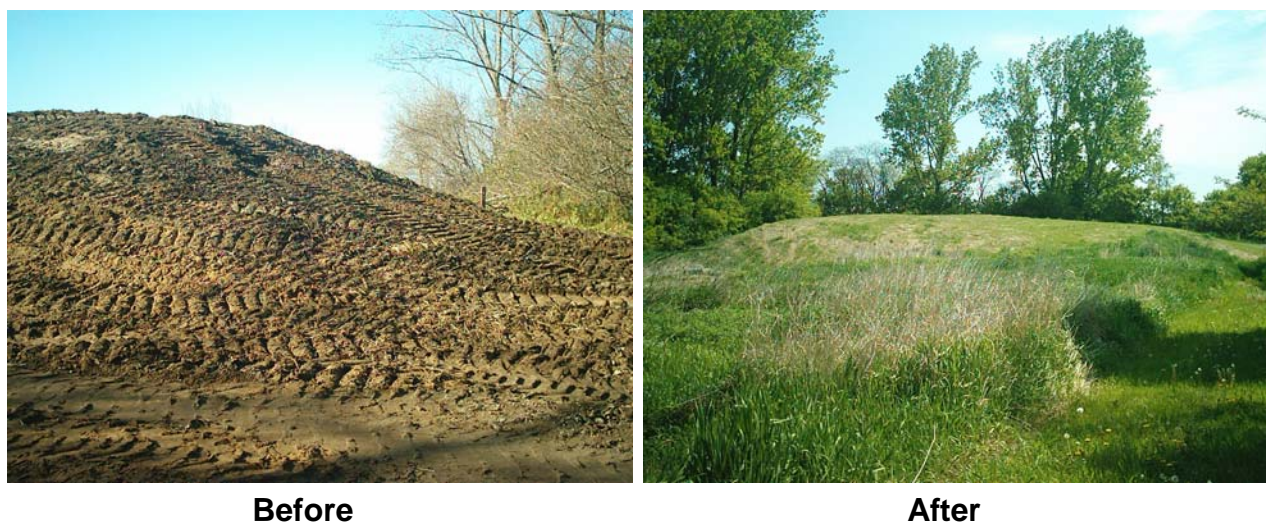
Fig. 4. Contoured surface of above ground storage mound before and after seeding with grass.

An elevation survey of the top of the waste fill within the contaminated area was carried out by Golder on October 27, 2009. The placement of final cover soil over the waste containment area commenced on October 29, 2009. The cover soil material consisted of silty fine sand. Approximately 1,250 m<sup>3</sup> of the cover soil was placed to a minimum thickness of 1 m over the waste and graded to provide surface drainage. Approximately 190 m<sup>3</sup> of topsoil stripped from the original cover was then placed to a thickness of 0.3 m overtop the silty fine sand cover soil. A survey of the top of the final cover was carried out by Golder on November 2, 2009. The cover placement was completed on this same date. The surface of the excavation area and storage mound were seeded with grass in the spring of 2010, as depicted in Figure 4.
