**Remote Visual Inspection of Hanford Site Single-Shell Tanks
Hanford Site, Washington, USA - 11335**

Jason K. Engeman*, Jessica P. Robocker*, Kayle D. Boomer*, Theodore J. Venetz*, Dennis J. Washenfelder*, Jeremy M. Johnson**

*Washington River Protection Solutions LLC, Richland, WA 99352

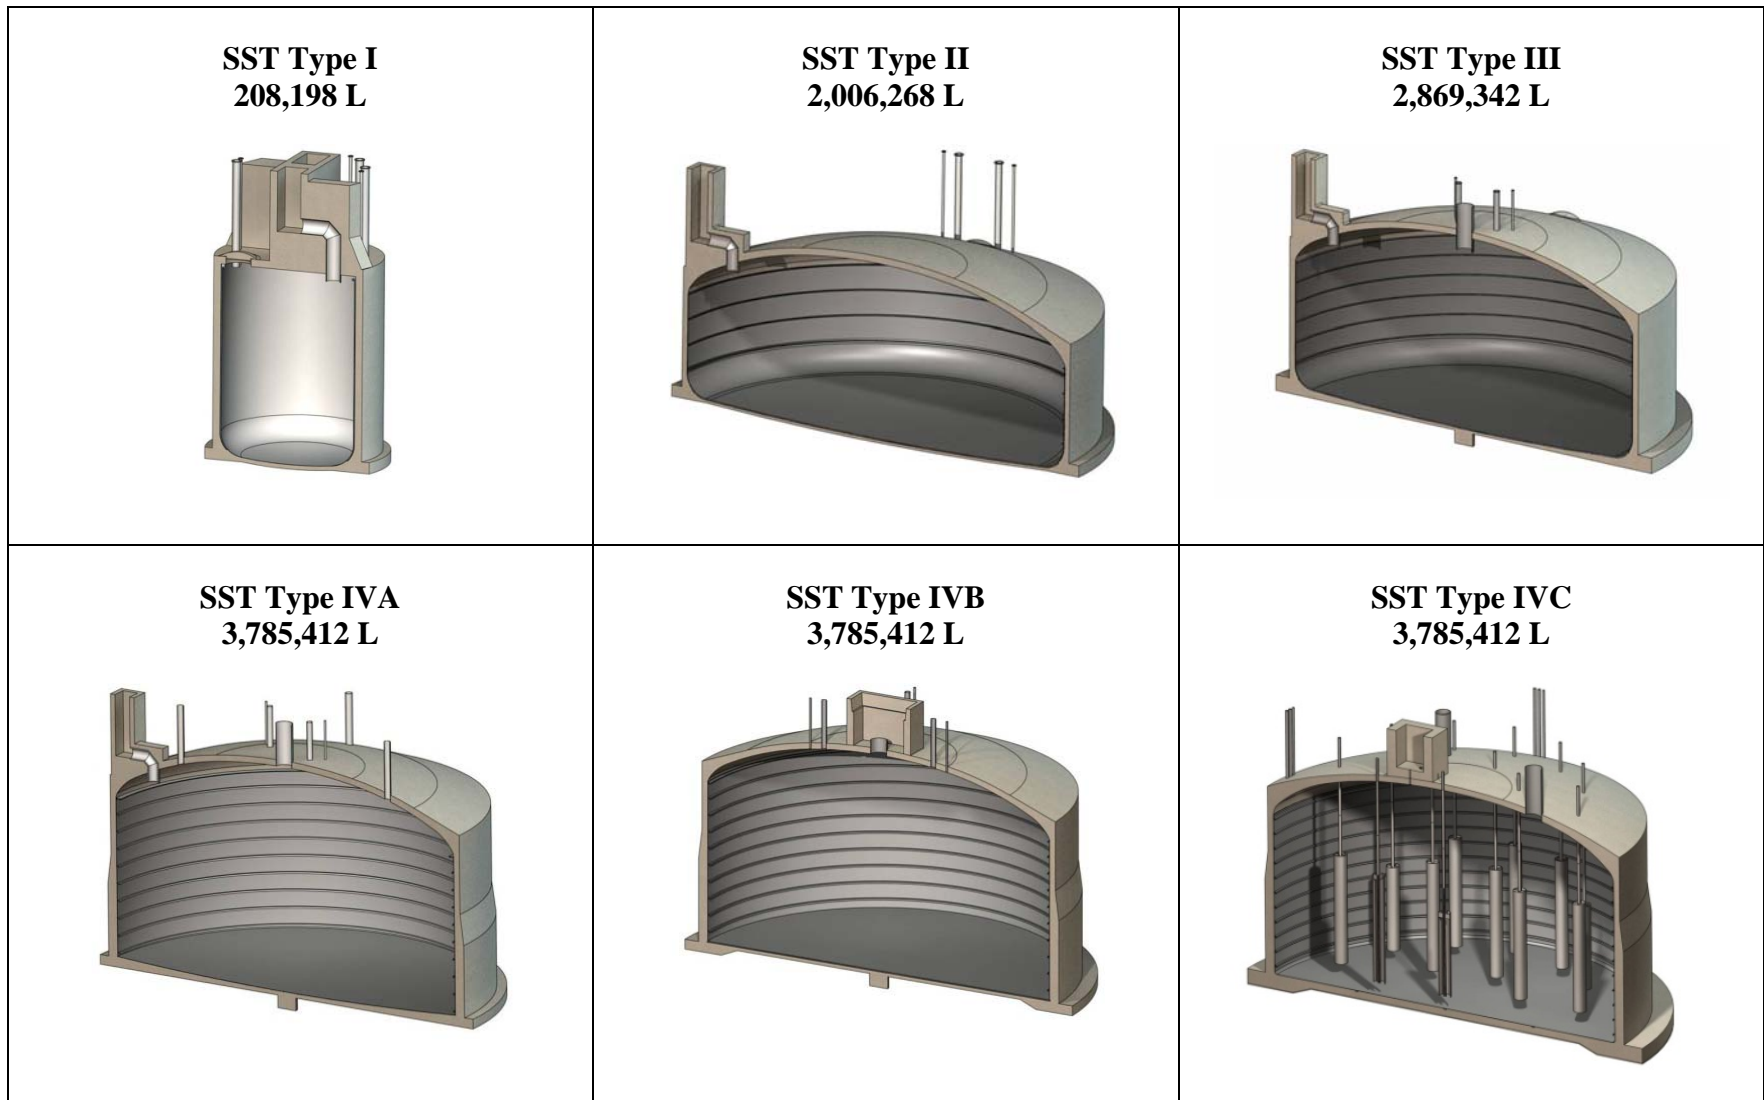
Fig. 1. Single-Shell Tank Types

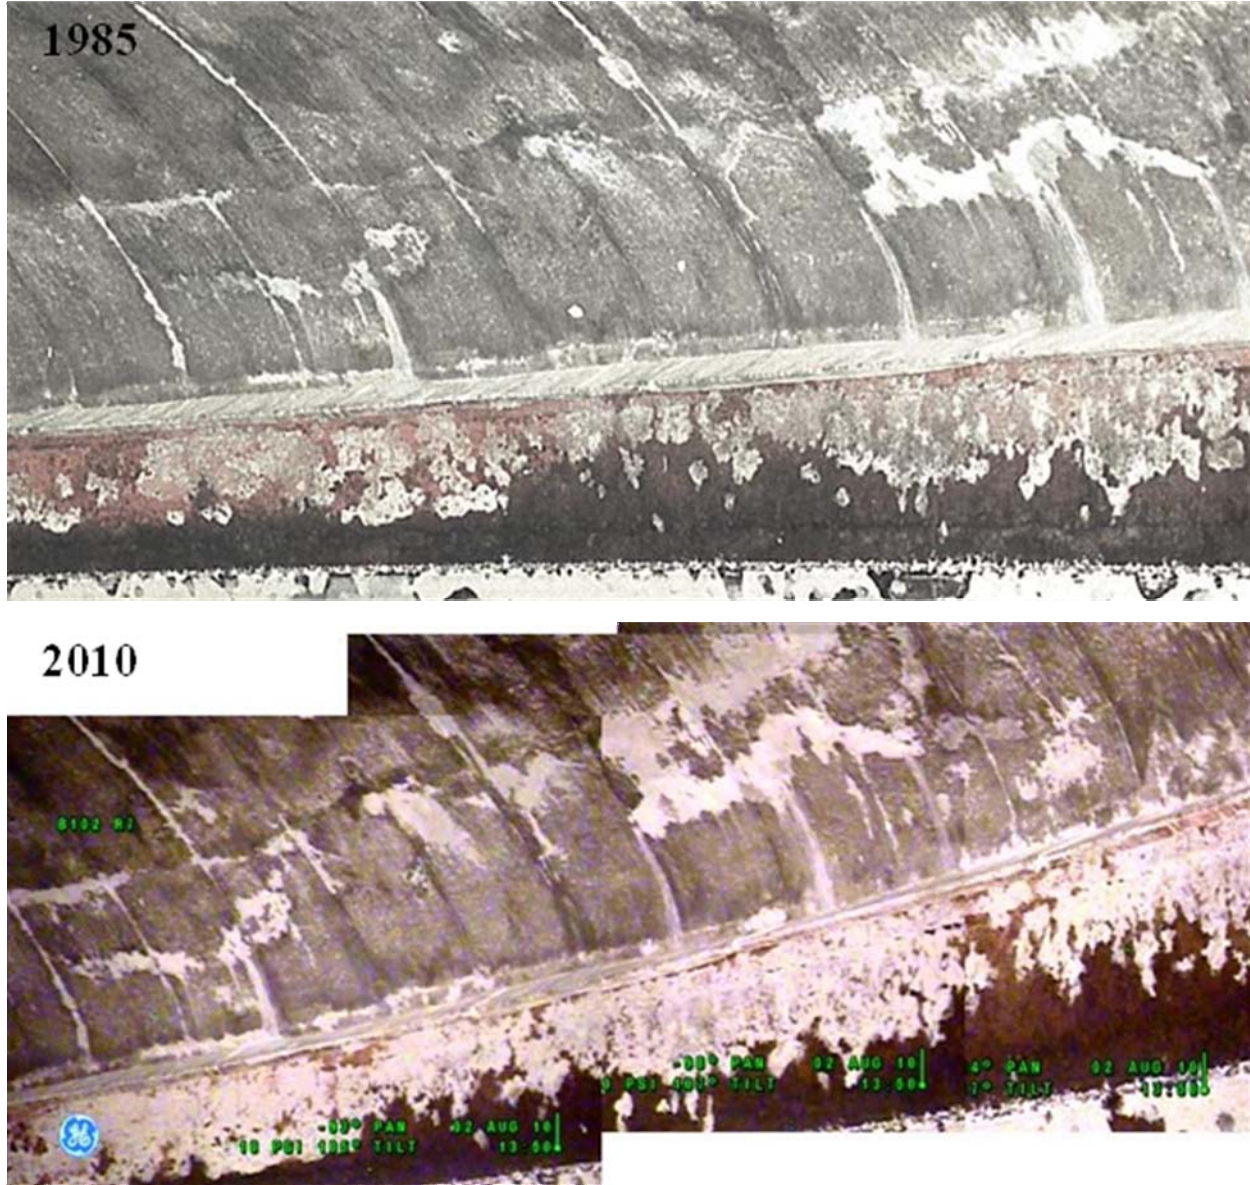
Qualitative comparisons are performed whenever possible to attempt to identify any changes in the tank's condition since the last in-tank inspection. Photographs of each SST have been periodically taken throughout their service life up until 1993. These photos provide a baseline for comparative changes in the tank condition. Figure 3 and Figure 4 provide examples of the tank haunch regions in tanks 241-B-102 and 241-C-110 compared to the condition in the 1985 and 1986 inspections.

Fig. 3. Comparative Photographs of Tank 241-B-102 Haunch Region

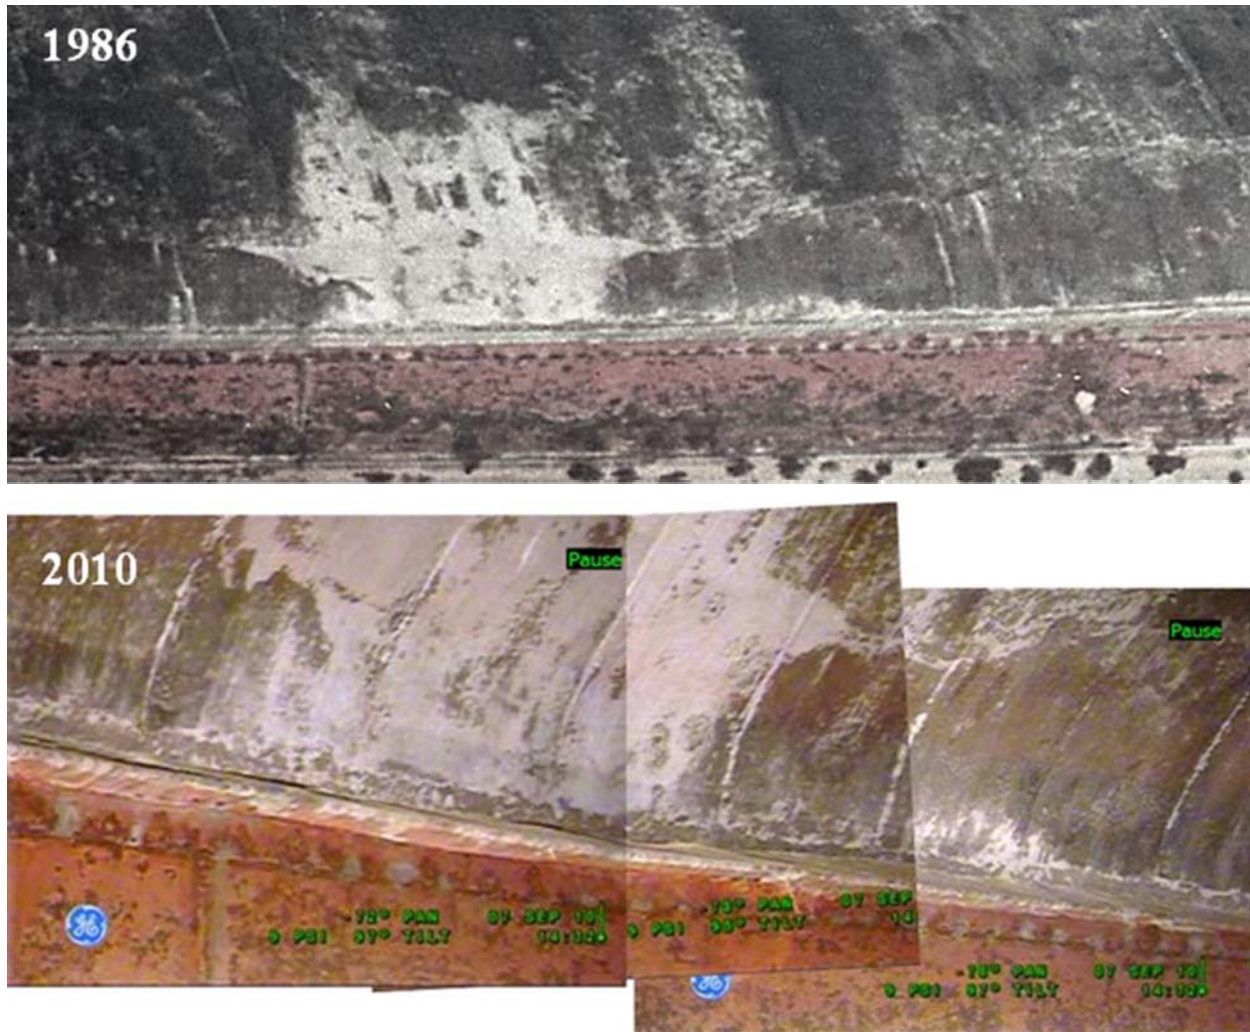
Fig. 4. Comparative Photographs of Tank 241-C-110 Haunch Region
