Long-Term Stewardship - Surveillance and Maintenance at Hanford - 15155

ABSTRACT

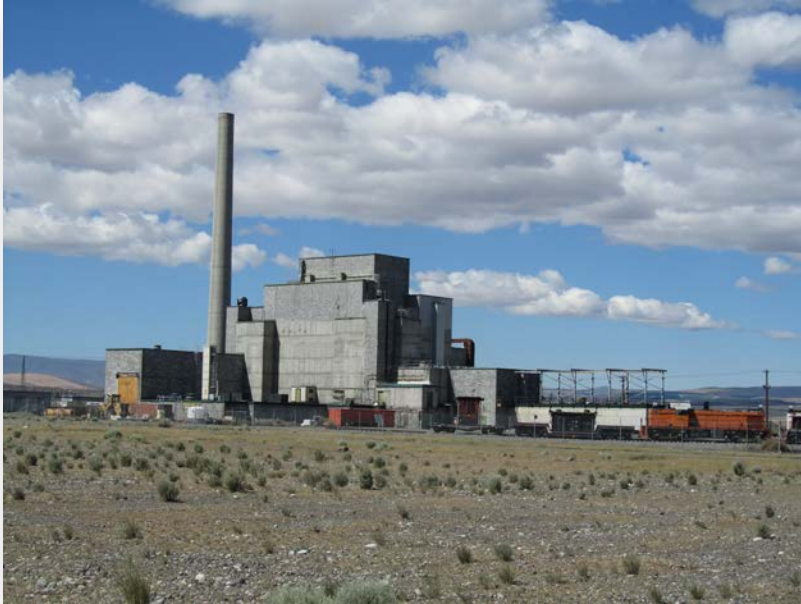
Figure 2: B-Reactor National Historic Landmark - no cocoon

105-F and 105-H, which ceased operations in 1965. The last reactor, the 105-N Reactor, shut down in 1987. The reactors were then deactivated and decommissioned and the auxiliary buildings were demolished, in accordance with a CERCLA removal action. Since then, the 105 B Reactor, the world's first full-scale nuclear reactor, has been designated a National Historic Landmark (Figure 2).

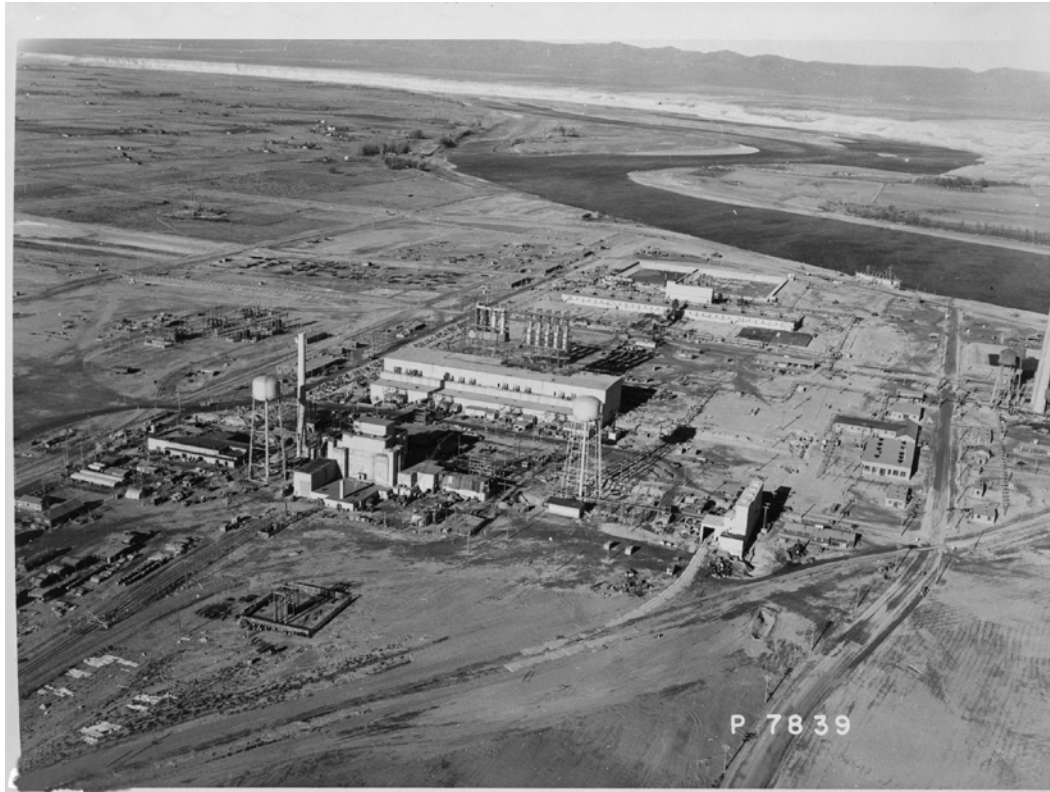
Figure 3: F Area Plutonium Production Reactor Complex

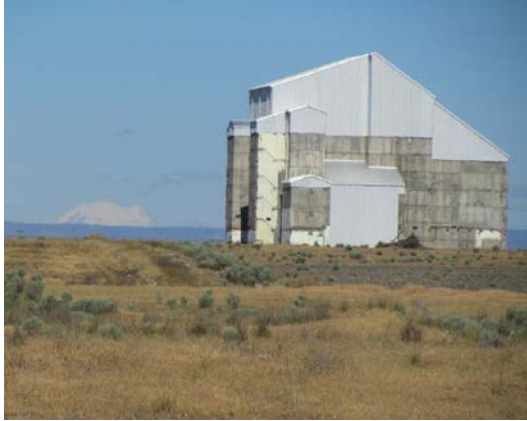
Based on the initial findings at 105-F, repairs will focus on minimizing biologic intrusions by sealing up exterior openings along seams and rooflines in the cocooned structure. The structural integrity of the cocoon (Figure 5), at least in 105-F, appears to be holding up to the elements well.

Figure 5: F Reactor after cocooning

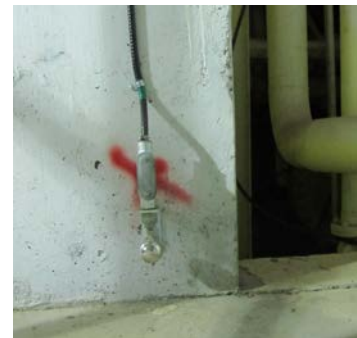
With the facility deemed safe to enter, the Instrumentation Technician was escorted to the temperature and moisture sensors (Figure 6) in the facility to check operability and evaluate the need for any maintenance actions. Temperature and moisture monitoring inside the cocooned reactor was an item negotiated amongst the regulatory agencies during the closure process. The conditions have been monitored monthly since 2008 with no outlier results. All equipment was found to be in good working condition with no need for replacement or repair.

Figure 6: F Reactor Moisture Sensor

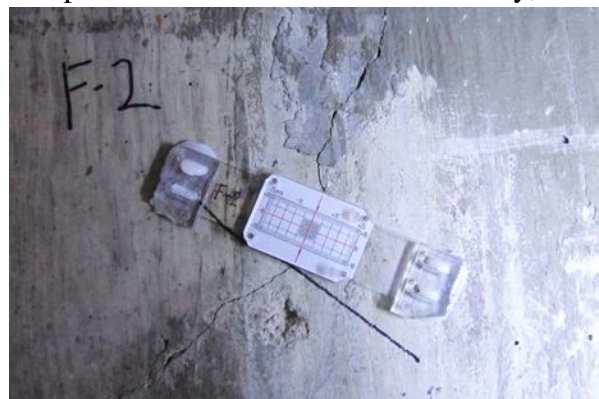
The structural assessment team reviewed the 2008 structural assessment report provided by WCH and confirmed all previous observations. Additionally, the entire structure was assessed, including the original construction concrete walls and stairs and the newer construction steel frame and siding. Photos were taken of items of interest and a full write up of the assessment was provided. In one location, the assessors identified a full penetration crack in the original concrete. This provided an opportunity to place a crack monitoring gauge for future empirical

8 *Figure 7: Crack Monitoring Gauge Installed at F Reactor*

evaluation (Figure 7). The gauge allows for objective evaluation of any movement during the next monitoring cycle.
