## **Characterization of a Contaminated Facility and Associated Soils in Support of D&D and Subsequent Soil Remediation – 15292**

A prime example of this is documented in the characterization of the 690-N, Process Heat Exchanger Repair Facility that had a history of PCB and radioactive contamination.

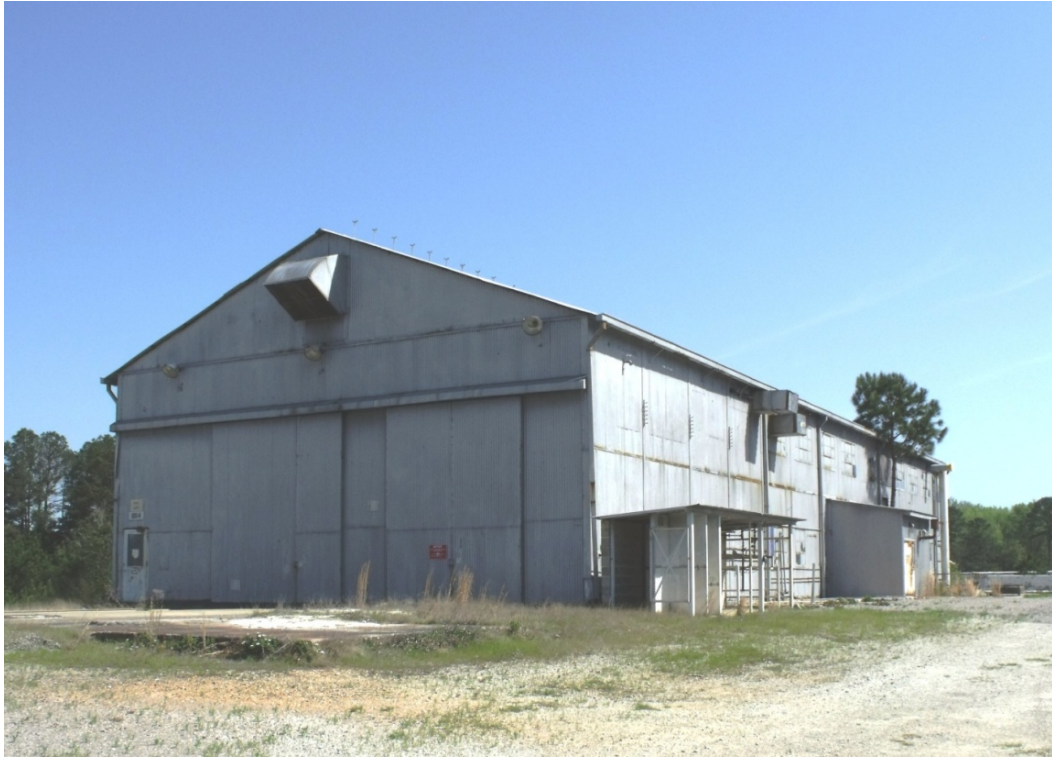
**Photo 1: 690-N (Ford Building) - Looking Northeast**

A steel containment hut was installed inside the facility to provide radiological containment for the heat exchanger rework. At the same time the steel hut was installed inside the facility, a process sewer drain line and process sewer floor drains were installed. The drain line was installed between the original Ford Building concrete floor slab and the newly expanded Process Heat Exchanger Repair facility where 20.32 cm of concrete was added, along with train rails, to handle the approximately 94 ton heat exchangers. The radiological contamination in the 690-N facility was due to the repair of the heat exchangers. This work continued until the 1970s. The facility had no installed chemical or radiological process systems and is classified as an “Other Industrial” facility in the SRNS “Standards/Requirements Identification List”.

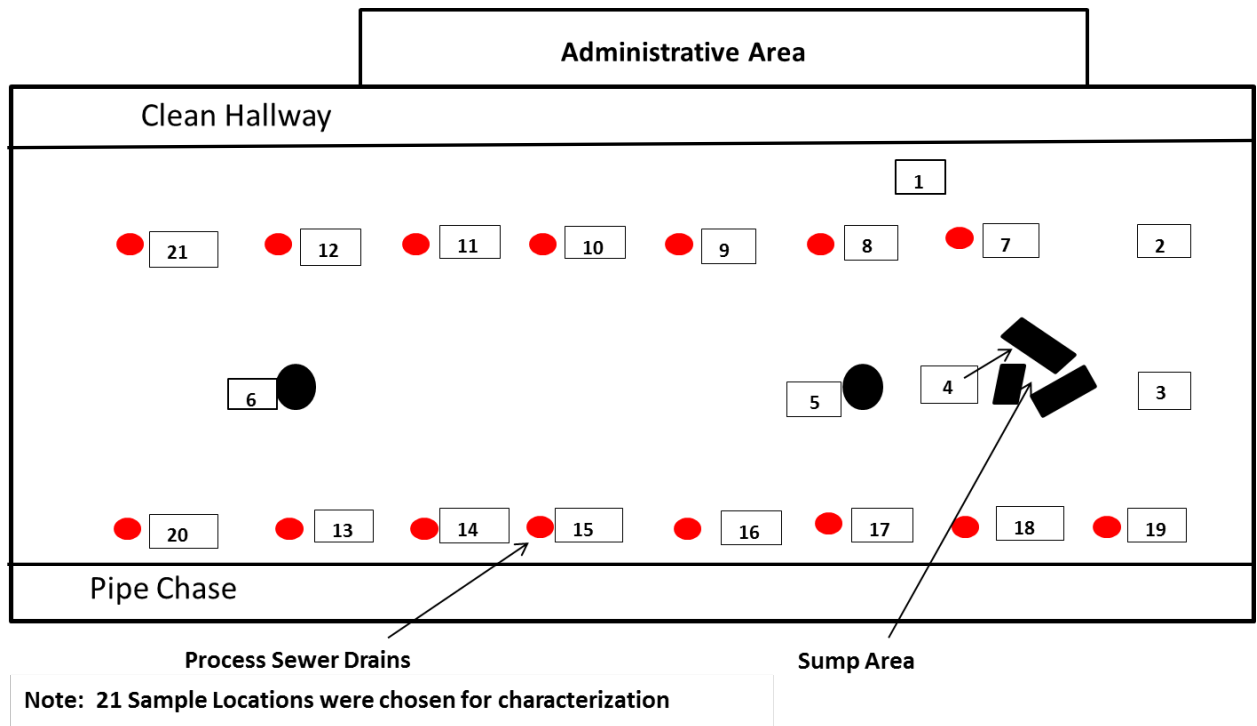
**Fig. 3. Core Sample and Rad Survey Locations**

The process floor concrete slab sampling was performed using a hammer drill method. Twenty one (21) locations were sampled (Fig. 3.). Prior to drilling, each sample location was radiologically surveyed to determine exposure potential for sample workers and to provide “screening level” characterization data. In order to obtain the required aliquot for the analysis requested, several drills were made per sample location for the 0 cm to 15.24 cm depth and then repeated for the 15.24 cm to 30.48 cm depth (Fig. 4.). At each drill location, a different drill bit was used for each depth, and the concrete sample (dust) was removed and bagged before proceeding to the next depth to avoid cross contamination (Photo 2). Each sample location included material from the 20.32 cm top concrete slab, which had been added when the facility was enlarged to be used as a repair/rework facility for the Heat Exchangers, and from the 10.16 cm lower (original) concrete slab when the facility was used for Ford Motor Company manufactured motor control packages.
