**In-Situ Visual Inspection of the CASTOR V/21 Used Nuclear Fuel Dry Storage Cask:  
A Demonstration of Camera System Capabilities – 15505**

Richard C. Williams, Al Carlson, David D. Tolman, and J.D. Tolman  
CH2M-WG Idaho, LLC

**ABSTRACT**

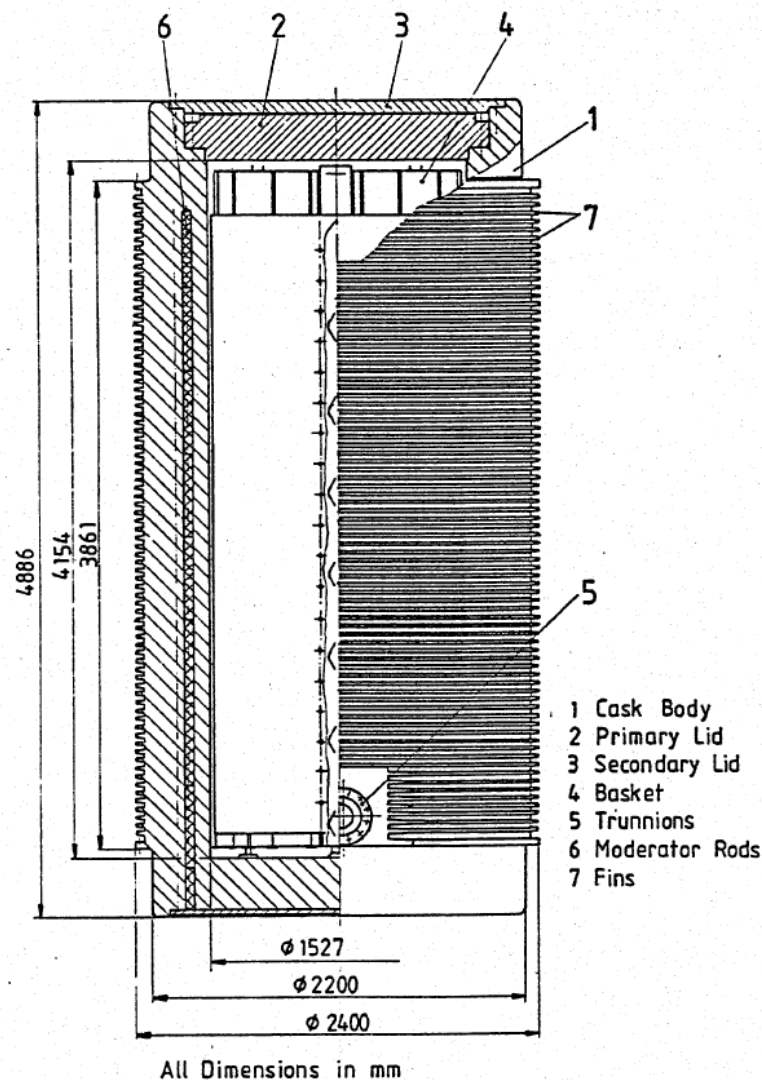
Fig 1. CASTOR V/21 Cask (GNSI, 1985)

The CASTOR V/21 cask is a one piece cylindrical structure composed of ductile cast iron in nodular graphite form. The overall external dimensions of the cask are 4.89 m (16 ft) high and 2.4 m (8 ft) in diameter (see figure 1). The external surface has 73 heat transfer fins that run circumferentially around the cask and is coated with epoxy paint for corrosion protection and ease of decontamination. The diameter of the inner cavity is 1.53 m (5 ft) and the overall inner cavity length is 4.15 m (13 ft - 7 in). The inner cavity surfaces, including sealing surfaces, have a galvanic-applied nickel plating (INEEL/EXT-01000183, 2001).

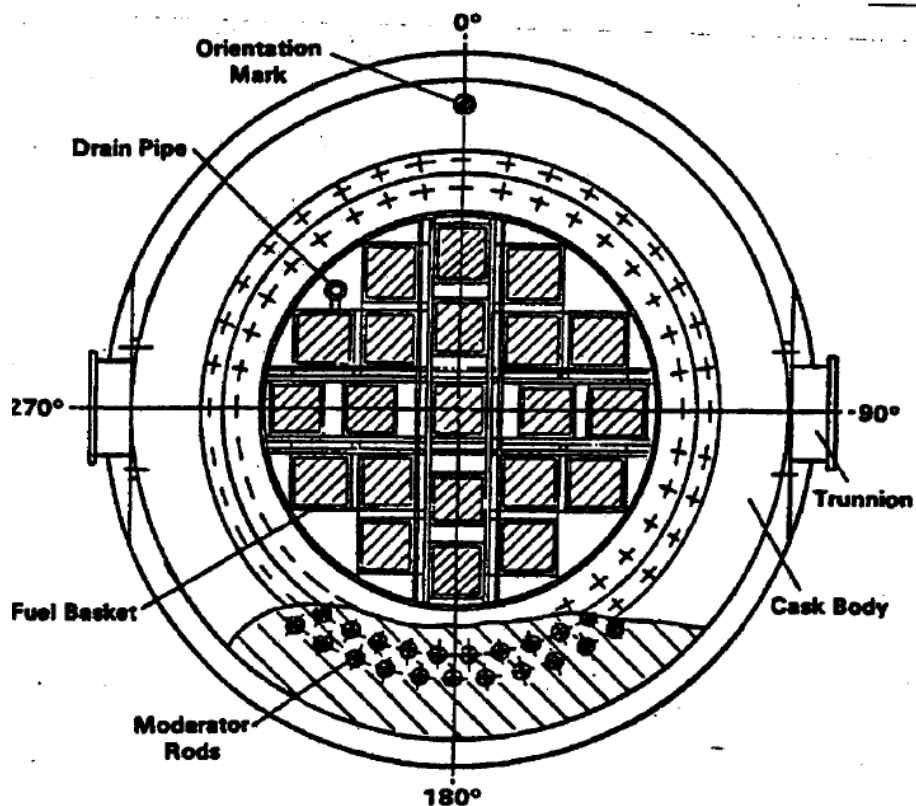
Fig 2: CASTOR V/21 Cask Cross Section (INEEL/EXT-01000183, 2001).

The spent fuel basket (see figure 2) is a cylindrical structure of welded stainless steel plate and borated stainless steel plate. The basket comprises an array of 21 square fuel tubes/channels that provide structural support and positive positioning of the fuel assemblies. The basket overall height is 4.11 m (13.5 ft) including the four 125mm (5-in) diameter pedestals that support the basket and fuel weight on the bottom of the cask cavity. The basket outside diameter of 1.53 m (5 ft) fits tightly in the cask cavity. A spacing of approximately 55 mm (2.3-inches) is present between the top of the fuel assemblies and the underside of the primary lid (INEEL/EXT-01000183, 2001).

A pipe with an inner diameter of 40 mm (1.6-inches) and a lead-in funnel at the top are welded to the side of a fuel tube near the outer circumference of the basket. The pipe location corresponds to a penetration in the primary lid and low side of the slope in the cask cavity bottom. The pipe provides a path for a flanged pipe used to fill and drain the cask (INEEL/EXT-01000183, 2001). The inspection described in section 2 utilized this primary lid penetration to access the cask internals.

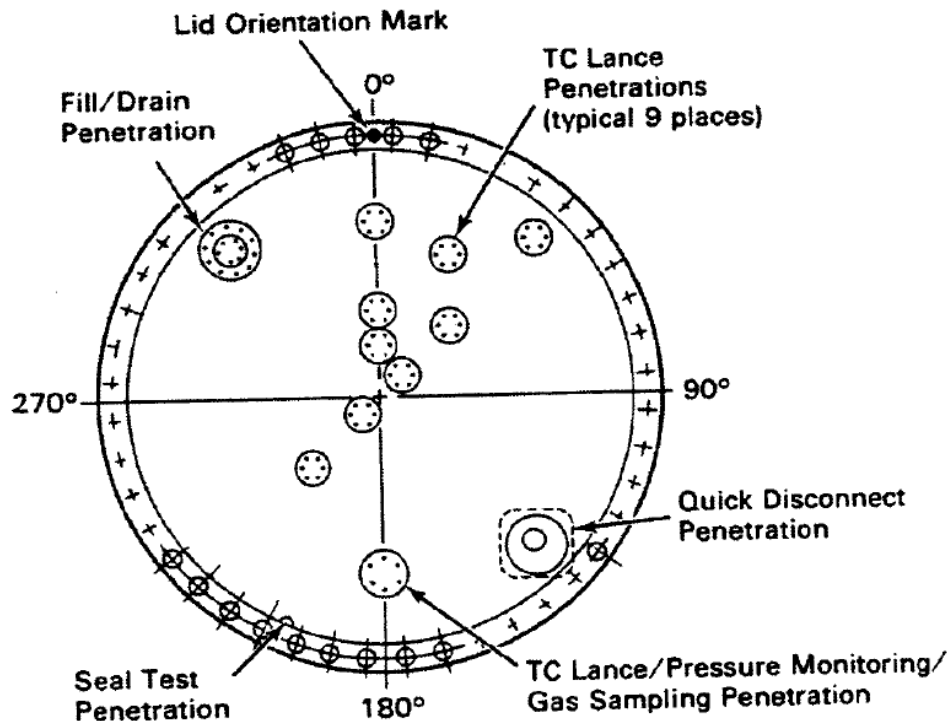
Fig 3: CASTOR V/21 Primary Lid (INEEL/EXT-01000183, 2001)

The CASTOR V/21 cask has a stainless steel primary lid that is approximately 1.8 m (6 ft) in diameter and 0.29 m (1ft) thick. A secondary lid, used in commercial application, is not used on the cask located at the INL because of interference with thermocouple lances, pressure monitoring, and gas sampling activities (INEEL/EXT-01000183, 2001)

Three penetrations through the primary lid are provided for various cask operations. A 35 mm (1.37-inch) straight-through penetration is used for water fill/drain operation and is located near the perimeter of the lid. This penetration is normally sealed with two flanges; the inner equipped with a shield plug extending the thickness of the primary lid and sealed with an elastomer O-ring. The outer flange is equipped with a metal “C” shaped O-ring. This fill/drain penetration will be used for the inspection. The other two penetrations, spaced next to each other and covered by a single flange, are also located near the lid perimeter, but 180 degrees from the fill/drain penetration. The through lid penetration at this location is equipped with a quick-disconnect fitting used for pressure monitoring, vacuum drying, and backfilling with gas (INEEL/EXT-01000183, 2001).

The primary lid on the CASTOR V/21 cask located at the INL is not a standard lid and has 10 additional penetrations for thermocouple lances (see figure 3).

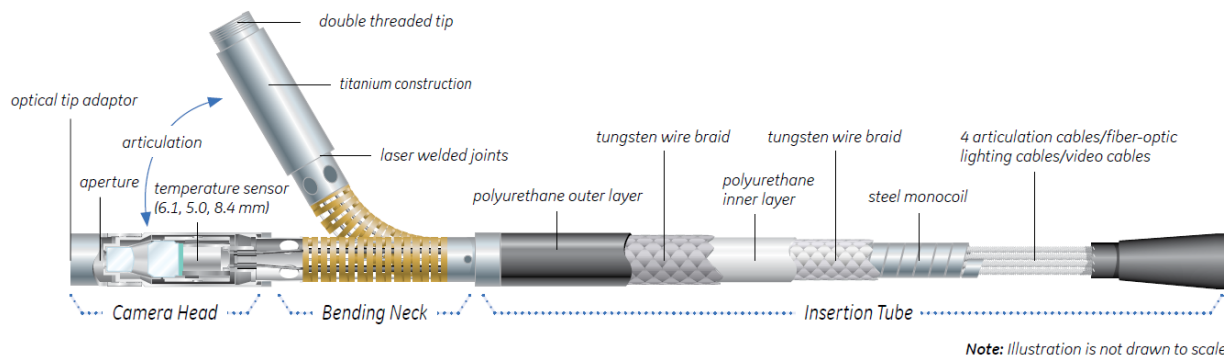
**Fig 4. Inspection Camera Technical Specifications (GE, 2010).**

The internals of the CASTOR V/21 were visually inspected using General Electric’s XLG3TM VideoProbe® which provides both qualitative (video and photos) and quantitative (3D Phase Measurement Technology) inspection capabilities. The 3D Phase Measurement creates a 3D surface scan of the viewing area and can measure all aspects of surface indications using a 3D scan (GE, 2010). See Figure 4 for a general diagram of the camera used for the inspection.

The published camera tip manufacture’s recommended operating temperature is  $-25^{\circ}$  to  $80^{\circ}\text{C}$  ( $-13^{\circ}$  to  $176^{\circ}\text{F}$ ) (GE, 2010). With the measured cask internal temperature of  $84^{\circ}\text{C}$  ( $182.9^{\circ}\text{F}$ ) slightly higher than the camera manufacturer’s recommended operating temperature, there was some concern about how well the camera would perform. The camera system provided a temperature warning as indicated by the yellow and red triangles in the top right corner of the video; however, the camera did not cut-out and performed adequately at the elevated temperatures.

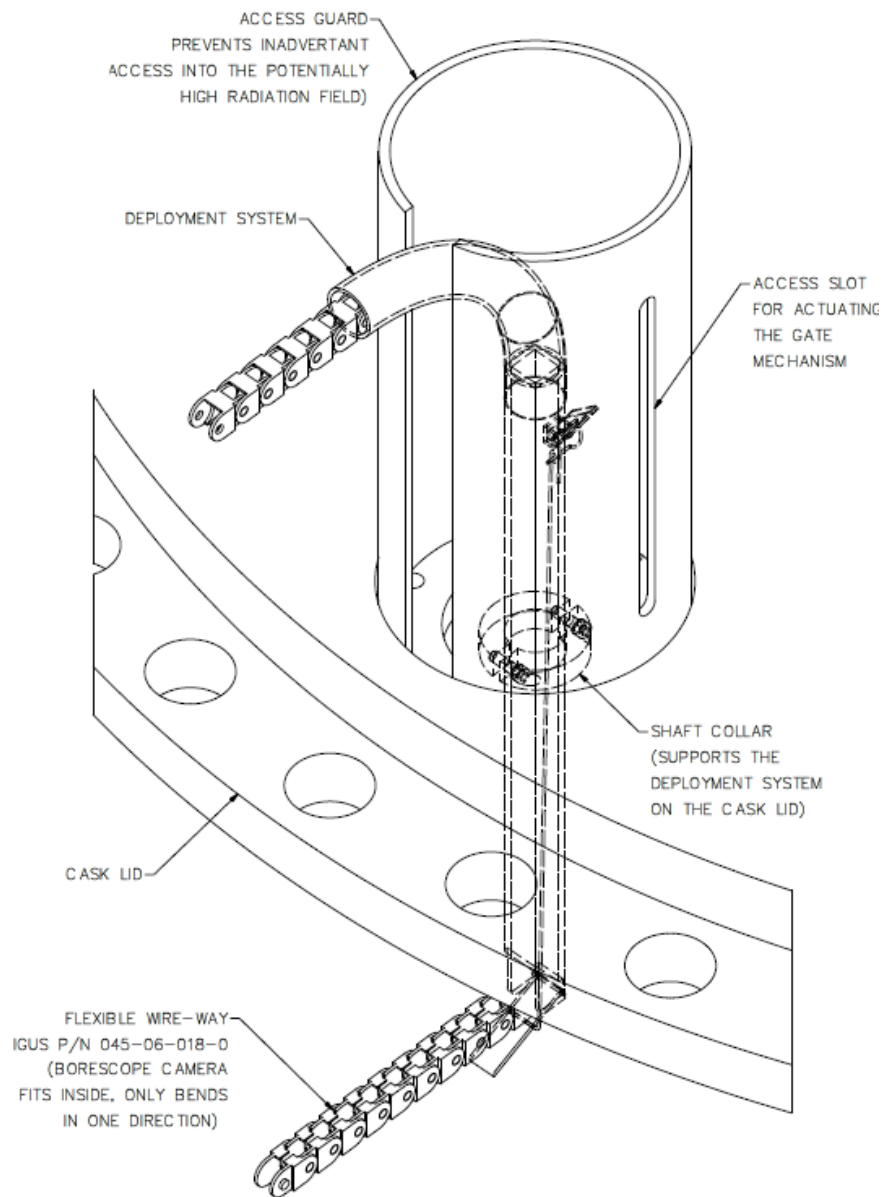
**Fig 5. CASTOR V/21 Camera Inspection Deployment System**

The camera is deployed using a custom system designed and built by the remote systems group at INTEC. It consists of a tube that fits through the CASTOR V/21 primary lid fill/drain penetration in which a flexible cableway that only bends in one direction can slide down. The flexible cableway houses the borescope camera and guides the camera horizontally within the space between the top of the spent fuel basket and the bottom of the cask primary lid (see figure 5).

The camera deployment system is designed in such a way so it can be operated outside of any direct radiation stream that would penetrate through the fill/drain penetration. An access guard prevents inadvertent access into the potentially high radiation field.

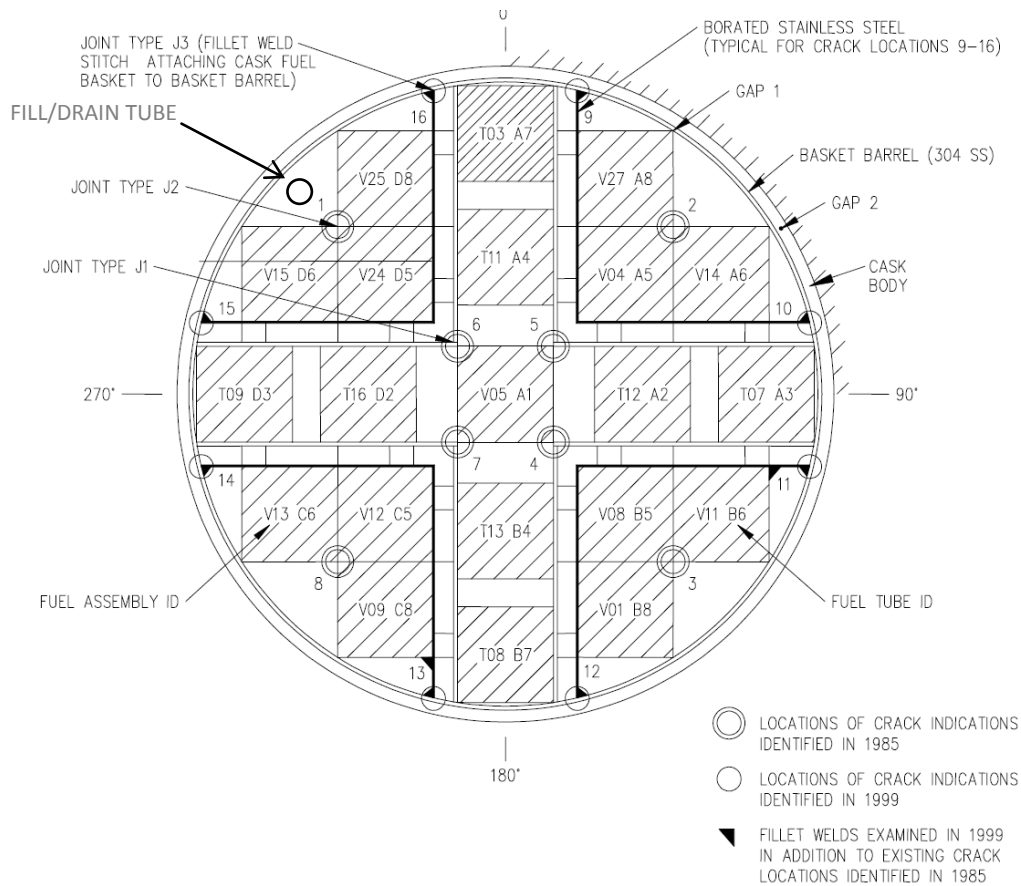
**Fig 8. Cracked Weld Locations (INEEL/EXT-01000183, 2001)**

The 1985 inspection of the basket after the completion of the heat transfer performance tests identified eight broken welds in the top of the basket (EPRI NP-4887, 1986). The welds cracked as a result of the stresses created by the differential thermal expansion of the tightly fitting basket within the cask during the testing (INEEL/EXT-01000183, 2001). One objective of the 2014 inspection was to determine if the cracked welds could be reexamined and to examine any other accessible welds in the basket structure for cracks or corrosion.

Figure 8 shows the locations of the previously identified cracked welds. For the 2014 inspection, weld location #1 was inspected because of its close proximity to the fill/drain penetration. The crack width of weld location #1 was measured at 0.48 mm (0.019-inch) and 0.38 mm (0.015-inch) as shown in figures 9 and 10 respectively. Figure 11 shows the crack at weld location #1 from the 1999 inspection. Although there was no measurement taken in the 1999 inspection, it does not appear that the weld has changed in size or appearance since that inspection.

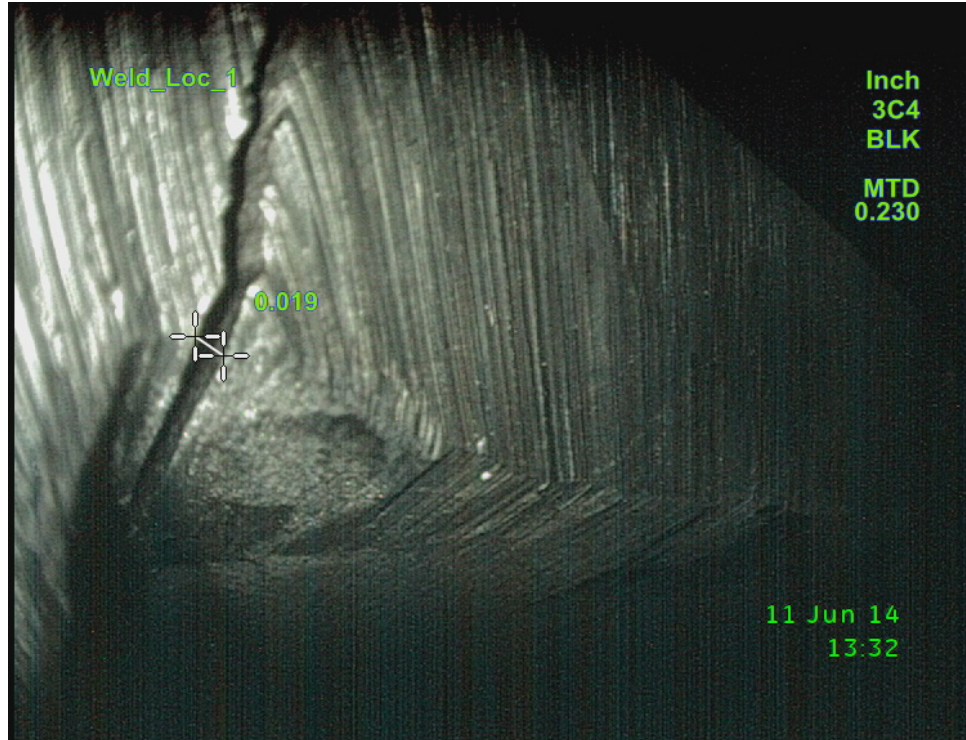
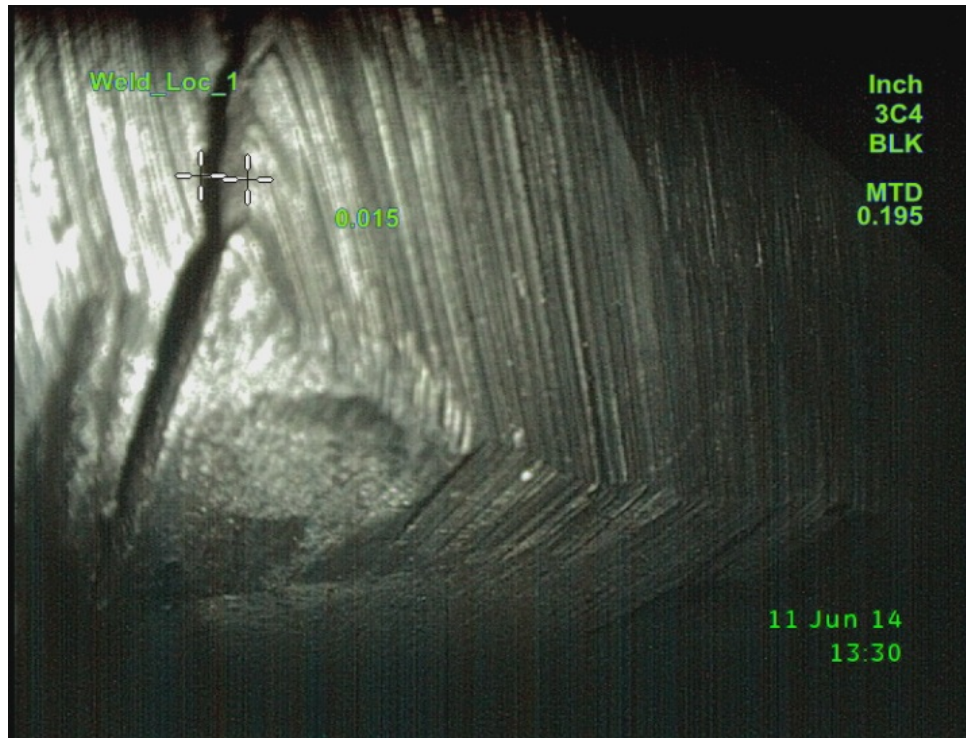
Fig 9. Weld Location #1 Measurement—2014 Inspection

Fig 10. Weld Location #1 Measurement—2014 Inspection

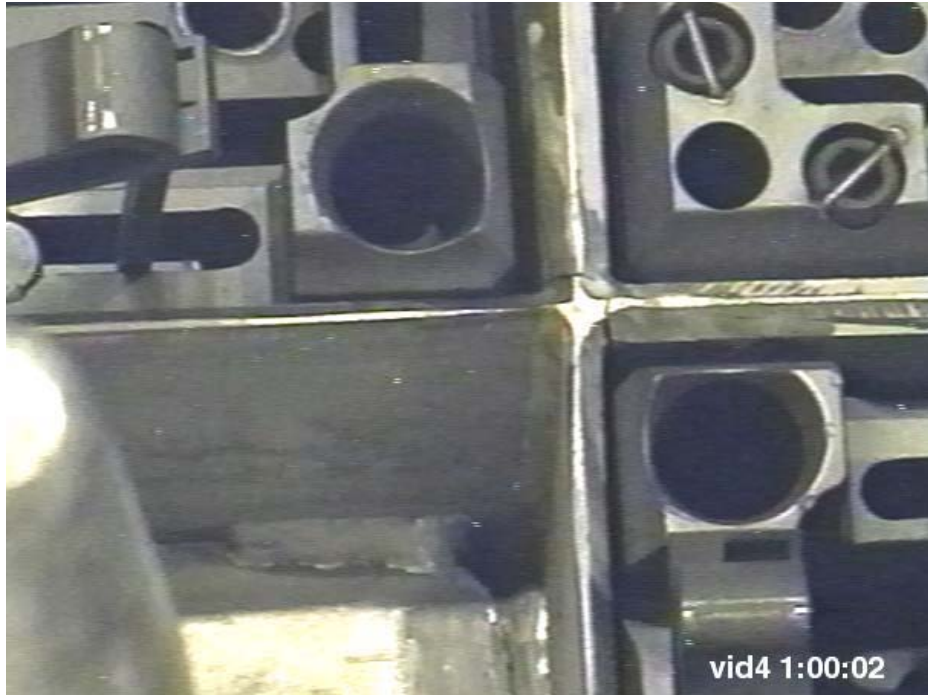
Fig 11. Weld Location #1--1999 Inspection (INEEL/EXT-01000183, 2001)

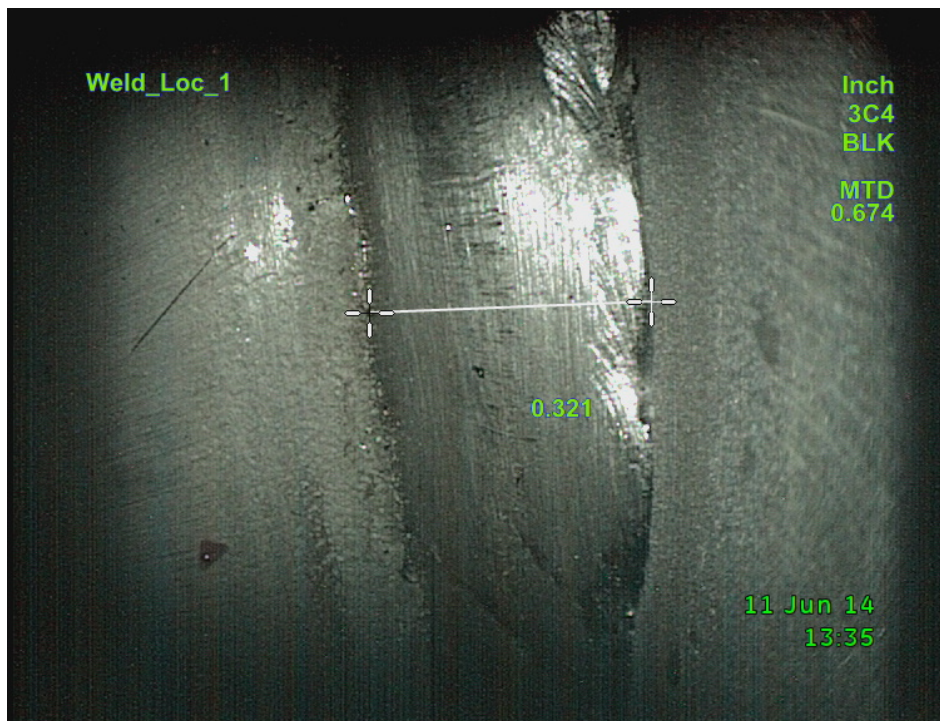
Fig 12. Intact weld inspection—2014

Figure 12 shows an intact weld on the fuel storage rack. It is free of corrosion and in generally good condition.
