The MacArthur Maze and Newhall Pass Fires and Their Implications for Spent Fuel Transport - 10536

Christopher S. Bajwa, Earl. P. Easton
U.S. Nuclear Regulatory Commission
Washington, DC 20555

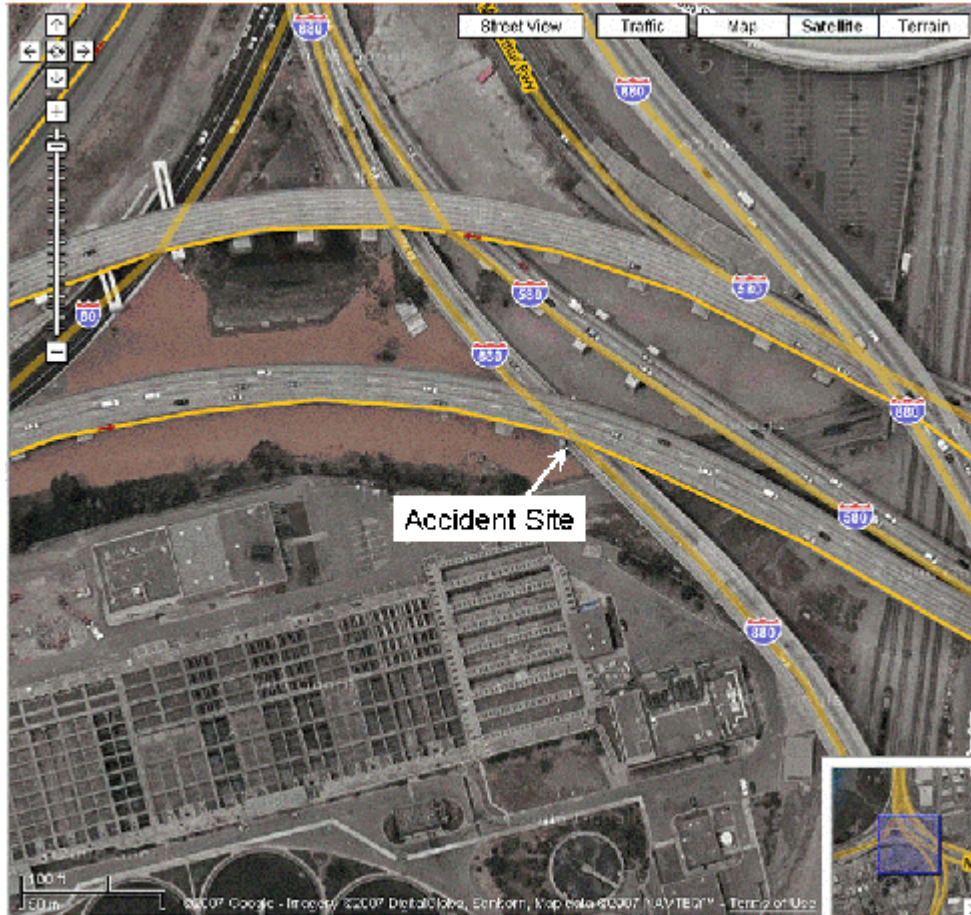
Fig. 1. Aerial photograph of I-880 and I-580 Interchange

The main portion of the fire, fueled by the gasoline leaking from the tanker, spread along a section of the I-880 roadway. Some of the gasoline went through the scupper drain on I-880 and burned on the ground around an I-880 roadway support pillar. The fire on the I-880 roadway heated the steel girders on the underside of the of the I-580 overpass to temperatures where the steel strength was reduced and was insufficient to support the weight of the elevated roadway. The I-580 overpass collapsed onto the I-880 roadway about 17 minutes after the fire started, based on surveillance video taken from a water treatment plant adjacent to the highway interchange. An aerial photograph of the area with the accident site identified is shown in Figure 1 [2]. A photograph of the scene after the fire was extinguished is shown in Figure 2¹ [3].

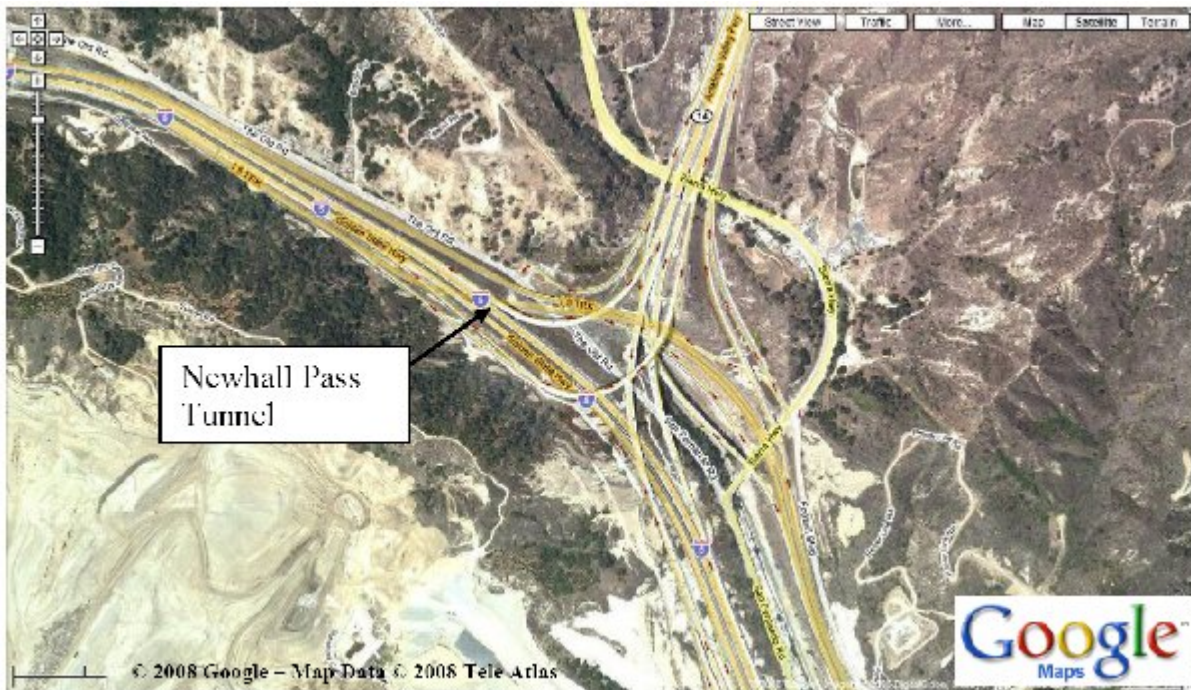
Fig. 4. Aerial Photograph of Interstate 5 and Highway 14 Interchange

On October 12, 2007, a major fire occurred in the Newhall Pass tunnel near Santa Clarita, California at approximately 10:40 p.m. The Newhall Pass tunnel is part of the Interstate 5 southbound truck lane as it passes below Interstate 5 main lanes. The tunnel is a 165.8-m [544-ft] long reinforced concrete boxed girder, which was built in 1971. The tunnel fire was a result of a truck accident that led to a 34-vehicle pile-up in and around the Newhall Pass tunnel. One of the vehicles caught on fire and ignited the other vehicles in the tunnel. It was reported that the fire appeared to emanate from both ends of the tunnel within 15 minutes of its start (See Figure 3). An aerial map of Newhall Pass tunnel is shown in Figures 4 and 5.

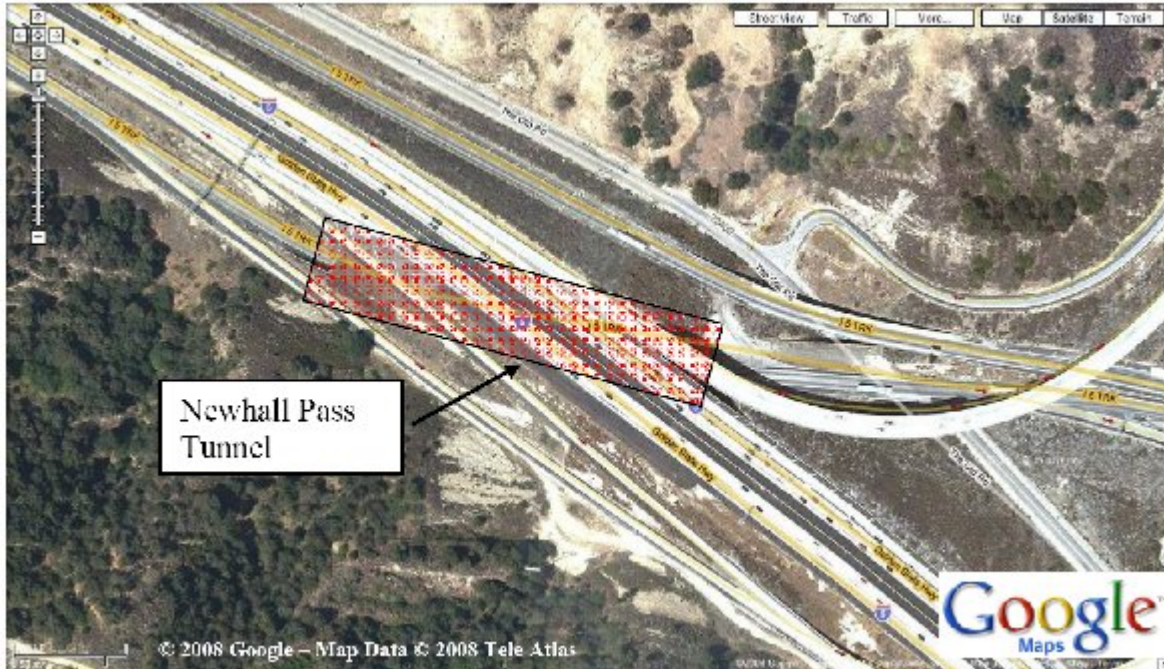
Fig. 5. Aerial Photograph of Interstate 5 and Highway 14 Interchange. The Accident Initiated on the Exit (Southwest Side) of the Tunnel.
