Fukushima Inspection Manipulator – 15485

Matt Cole, Kurion

ABSTRACT

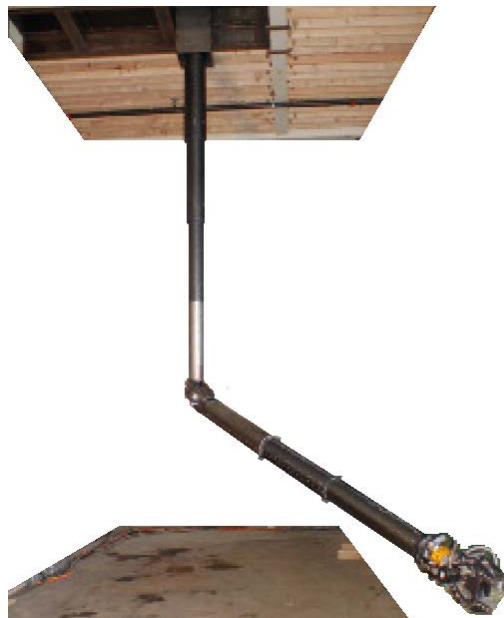
Fig. 5 – FIM Deployed in Colorado Mockup Demonstrating Long Reach Capabilities

The FIM is then rigidly connected to the cable management frame. The system has a number of tools which can be connected to the front of the FIM. This is done manually although all operations inside the reactor building have been designed to be done with minimal time and while wearing extensive protective equipment. Once a tool has been connected, the manipulator is installed into the penetration and the entire arm is flipped and unfolded into the hole. This folding allows a very long manipulator to be stored and transported in the frame of the FIM.

The manipulator arm is composed of a main mast with five telescoping carbon fiber sections. This mast is rotated to allow positioning of the arm below the hole. On the end of the telescoping mast is a double elbow which allows 180° of rotation of the arm. After the elbow is a telescoping forearm section followed by an articulated wrist and remote tool plate.

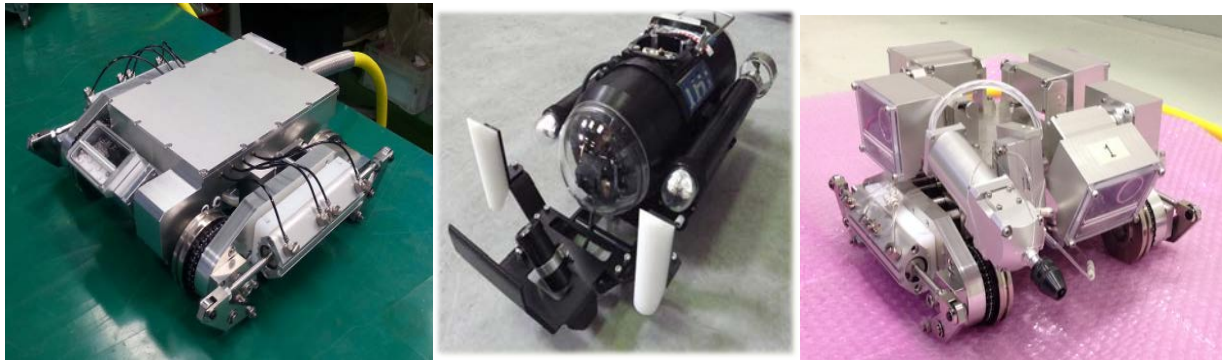
Fig. 6 – Picture of 3 IHI ROVs used in Inspection (Left-Right: Vent Tube, Down Leg, Suppression Chamber)

Each ROV is designed to inspect a different area of the lower part of the PCV for leaks and is designed to match this geometry. The first ROV is a magnetic crawler that is designed to crawl along the body of the suppression chamber and look for leaks along this large steel structure. The second ROV is also magnetic but is designed to crawl along the vent tube to inspect the joint between the vent tube and main body of the PCV. The last ROV is a submersible which can swim through the water at the bottom of the Torus Room.

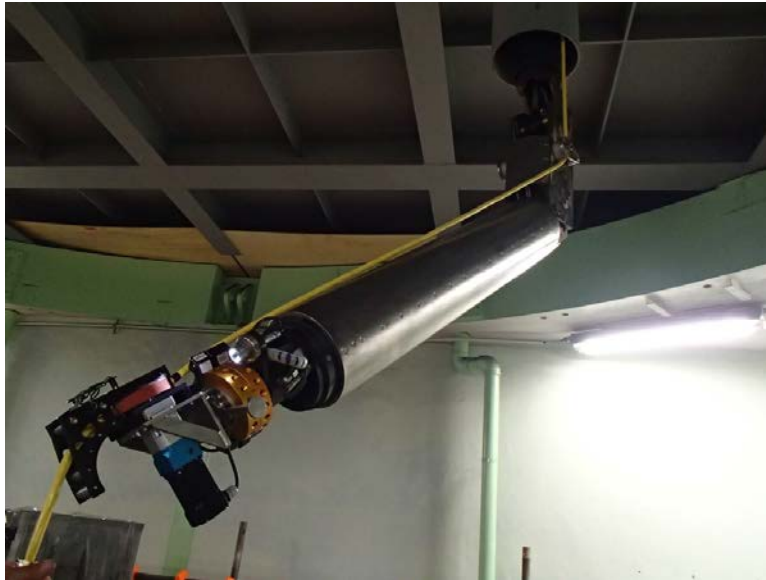
Fig. 7 – Picture of FIM and ROV Deployment Tool during Testing at IHI Mockup

In May of 2014 Kurion finished the design and fabrication of the FIM, cable management system and tools. All this equipment was tested with the support of IHI in Kurion's Colorado facility before being shipped to Yokohama Japan for a full system test in IHI's large mockup. This final test included the Toshiba and IHI developed ROVs and also included training for the operators that would be supporting
