CHARACTERIZATION OF THE NUCLEAR BARGE *STURGIS*

Hans B. Honerlah, CHMM
U.S. Army Corps of Engineers, Baltimore District
10 South Howard Street, Baltimore, Maryland 21201

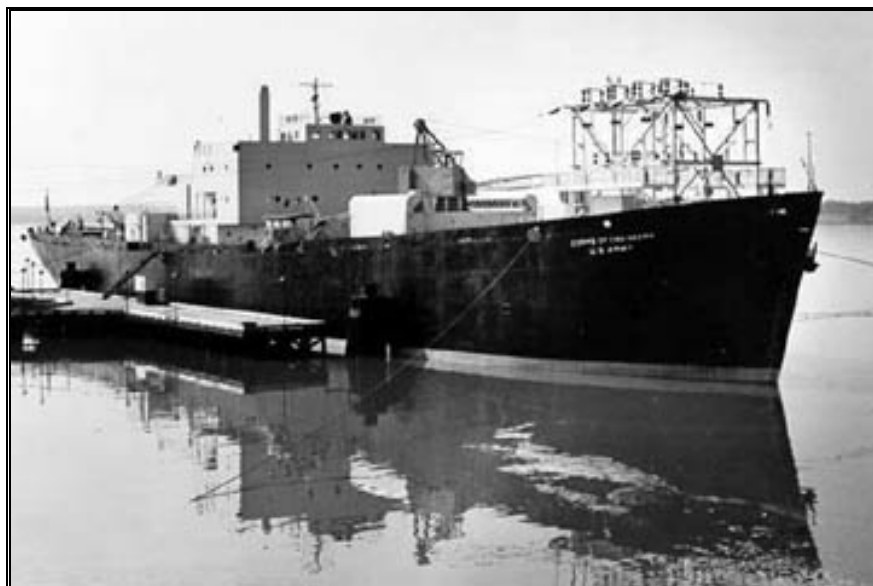
Fig. 1. Operational testing of the *Sturgis* at Ft. Belvoir, VA. (Corps photo)

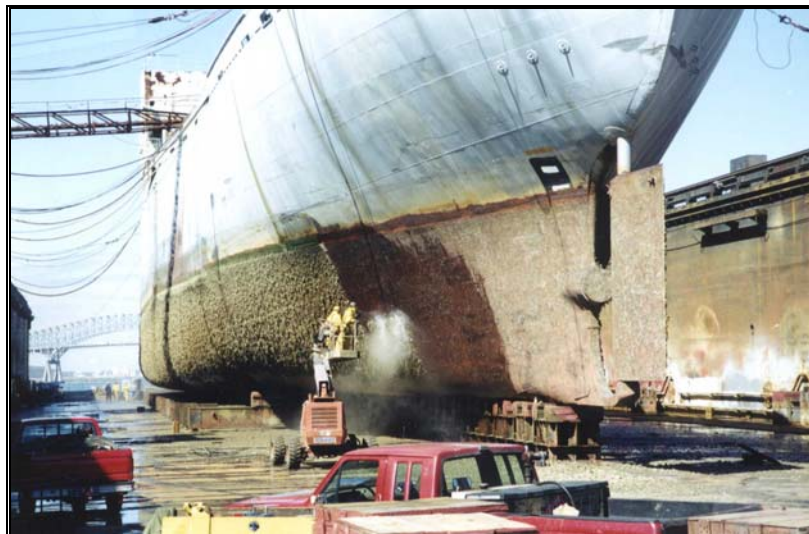
Fig. 2. Cleaning of the hull during 1999 dry dock. (Corps photo)
